# Franklin County Board of Zoning Appeals

**MINUTES OF THE  
FRANKLIN COUNTY BOARD OF ZONING APPEALS**

## CU-3922

# **Leaching Characteristics of Asphalt Road Waste**

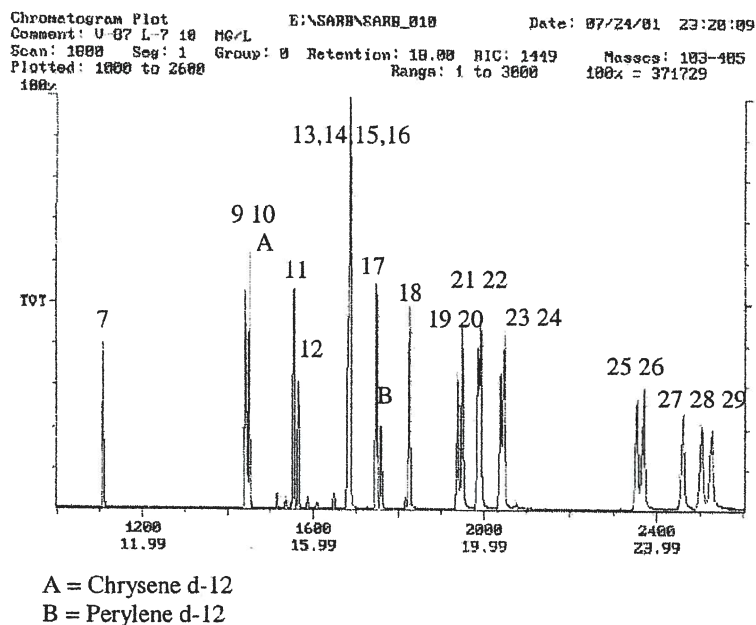
**FIGURE 1.** A chromatogram of a 10 pg/ $\mu$ L calibration standard of the 22 EPCRA compounds. The order of elution is outlined in Table 5 for compounds 7 to 29.

Using a Varian Saturn 4 GC/MS/MS, the column (a 25 m  $\times$  0.25 mm ID BPX5 0.25 micron film SGE Cat # 054113) was held at 150°C for 3 min and then increased to 300°C at 10°/min and held for 15 min, then increased to 320°C at 2°/min kept for 2 min. With a CT 8200 autosampler, the solvent plug 0.2  $\mu$ L with upper and lower air gap and sample volume of 2.0  $\mu$ L was programmed with air-dry after wash at an injection rate of 5.0  $\mu$ L/sec and hot-needle time of 0.04 min. The mass range was 100 to 410 m/z and the scan time 0.600 sec, segment length 30 min, filament delay 2.70 min, mass defect 40 m $\mu$ /100  $\mu$ , and background mass 98 m/z. Most importantly, the injector was at 320°C (deactivated 1078 glass insert with glass wool-Varian Cat no. 392611953), transfer line at 325°C, and the trap temperature at 285°C. An internal standard quantification procedure was used. A total of seven calibration standards (dilutions of a custom mix prepared by AccuStandard, USA) were analyzed to provide a concentration range of 0.1 to 10 pg/ $\mu$ L. Figure 1 shows a chromatogram of the 22 compounds on the EPCRA

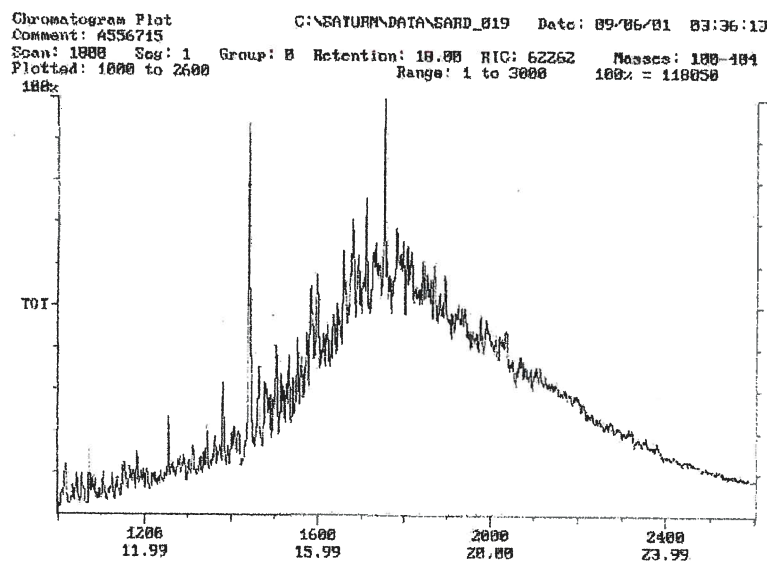
**FIGURE 2.** A chromatogram of paving sample 2. The complexity of asphalt analysis is evident. This injection is of the DMSO extract, which is even cleaner than the corresponding ACN extract.

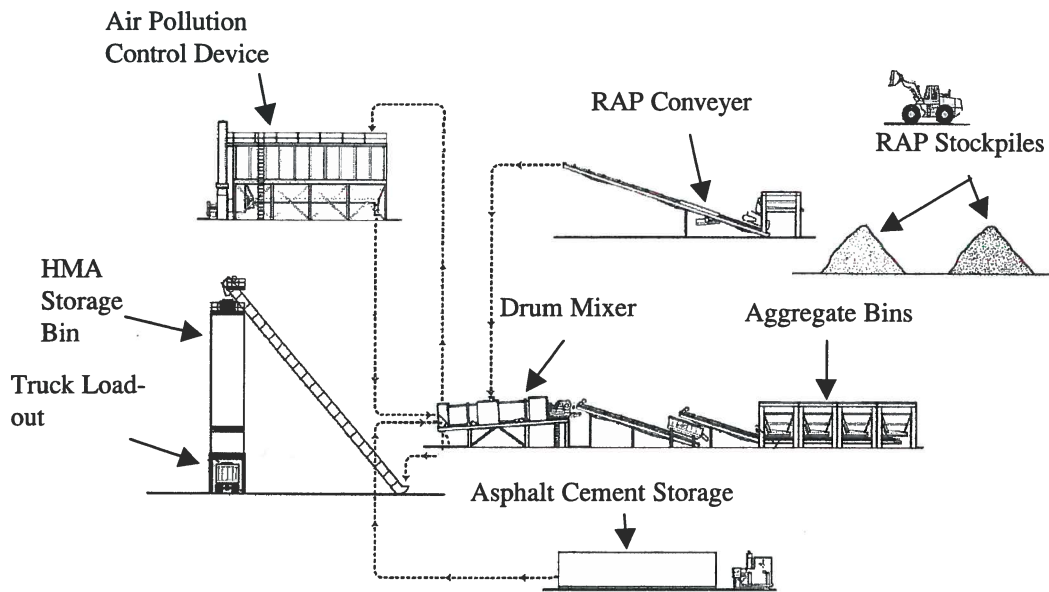
**Figure 2.1 Typical Site Layout of a HMA Plant (Adapted from EPA, 1997)**

Detailed descriptions of asphalt production and roadway construction have been presented elsewhere (NAPA, 1997), but a general overview is presented here. The most typical type of asphalt mixture produced is hot mix asphalt (HMA). HMA is generally a combination of 95% aggregate (rock, gravel, sand, or stone) and 5% asphalt cement. These percentages can change according to the specifications of the road being constructed. A typical site layout of a hot mix asphalt facility is shown in Figure 2.1.

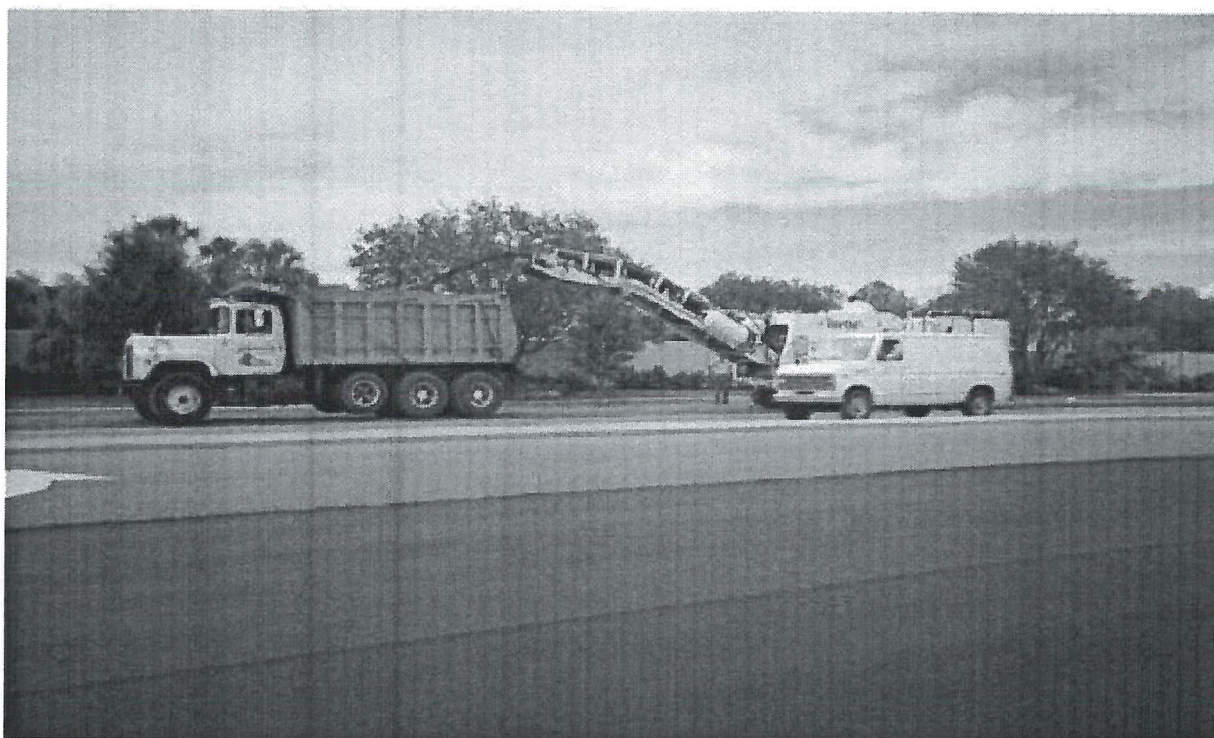
**Figure 2.2 Typical Roadway Excavation Process**

asphalt plant and re-used in a new asphalt mixture. This milled material is what this report commonly refers to as reclaimed asphalt pavement (RAP).

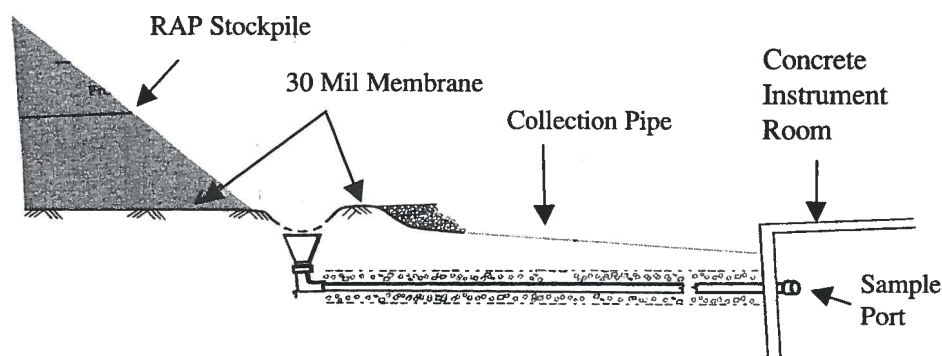
**Figure 2.3 Site Layout of Experimental RAP Pile (Sadecki et al., 1996)**

A pile of RAP was placed on top of a plastic liner open to the environment. The liner was an impermeable barrier that allowed the leachate produced to be collected. Leachate was automatically collected by a catch basin and periodically collected and tested. The site layout is shown in Figure 2.3. The Minnesota Department of Health Laboratory, using US EPA approved methods, analyzed the leachate samples. Some physical tests were performed including: pH, conductivity, turbidity, total solids, total dissolved solids, and alkalinity. The leachate collected was also tested for metals and PAHs.

The primary concerns encountered in the leachate from the RAP material reduced to solids, pH, and chromium. In some instances, the dissolved solids were detected at levels higher than the secondary drinking water standards. The sediments washing from a pile could potentially cause erosion problems by forming deltas and reducing the depth of an aquatic habitat. The median pH value of the RAP material (8.1) exceeded the Minnesota standard of 8.0 for surface water quality suitable for fishing and recreation. Chromium also exceeded the standards for surface waters. It was concluded that chromium could have resulted from the wearing metal on vehicles or could have been in the slag aggregate (a by-product of steel making) used to make asphalt. PAHs are always a concern when dealing with RAP because of the possible carcinogenic effect it might have. PAH concentrations from the RAP material were nearly at or below detection limits.

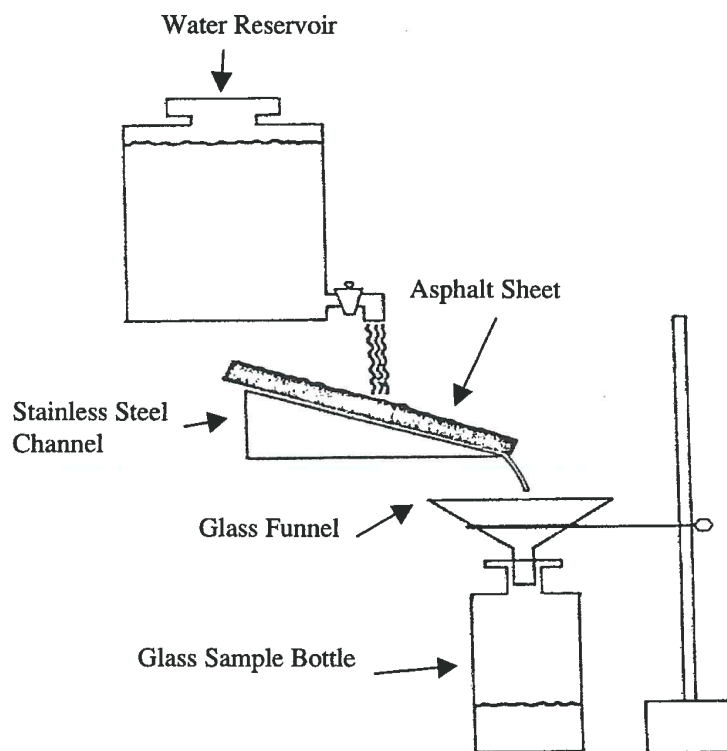
**Figure 2.4 Experimental Setup (Byrne, 1980)**

Results for this experiment are presented in Table 2.7. In the winter simulation sample, the initial runoff was higher than that of the control. It was ascertained that this might have indicated “oil bleed” into the initial runoff. All other sample times resulted in hydrocarbon concentration less than the control. In the summer simulation sample, five out of the six samples resulted in higher concentration than the control. It was concluded that there was a possibility of organics being leached from asphalt during an extended period of time. It was also suggested that an increase in temperature during summer months could also result in an increase in hydrocarbons released into stormwater runoff.

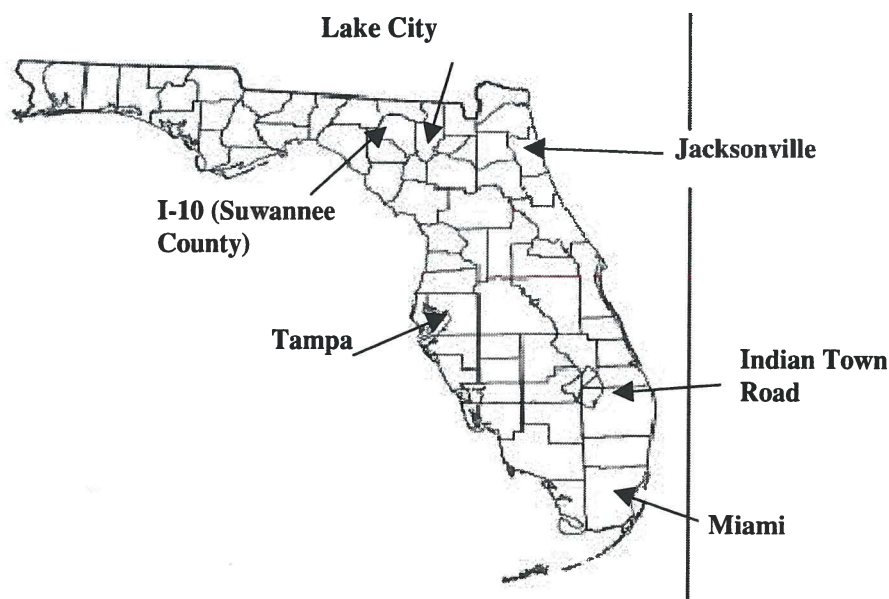
**Figure 3.1 Sampling Locations throughout the State**

Facility/Sample Location	Date Sampled	Sample Pile Description
Miami	September 16, 1997	½" Crushed mixed source pile
Tampa	September 16, 1997	¾" Crushed mixed source pile
Jacksonville	October 2, 1997	¾" Crushed mixed source pile
Lake City	October 2, 1997	¾" Crushed mixed source pile
SR -8 (I-10)/ Suwannee County	October 2, 1997	½" Milled asphalt
Indian Town Road/ Palm Beach County	November 25, 1997	½" Milled asphalt

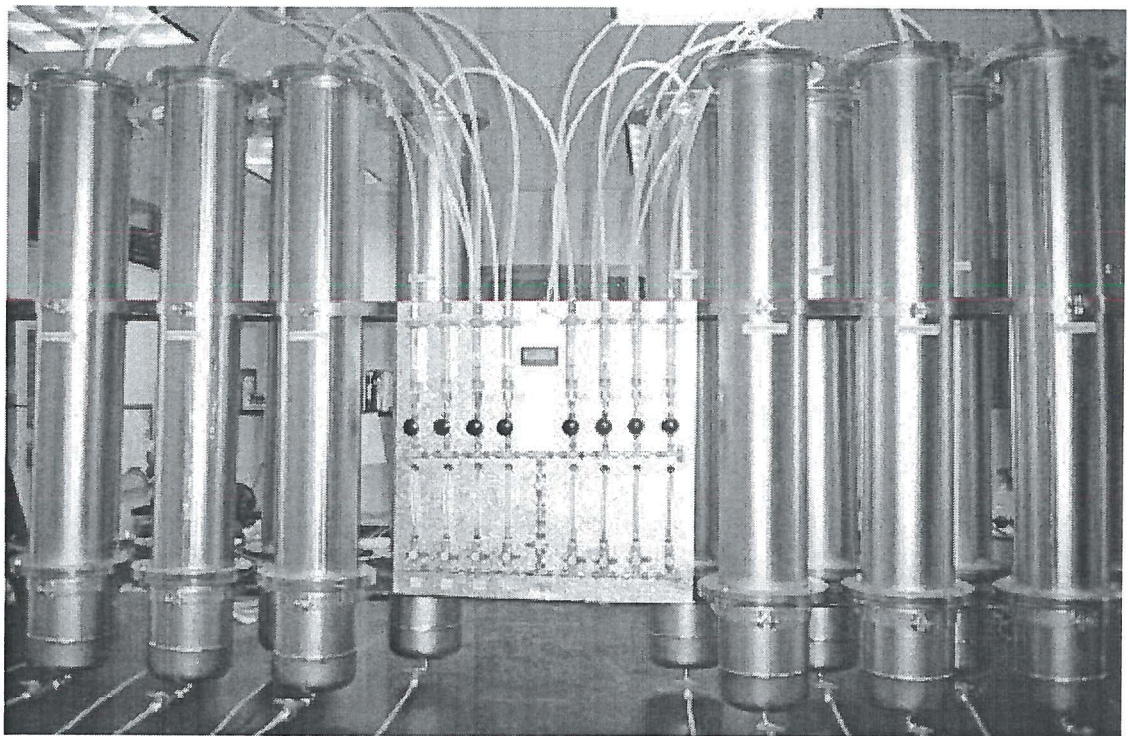
**Figure 3.2 Column Leaching Apparatus**

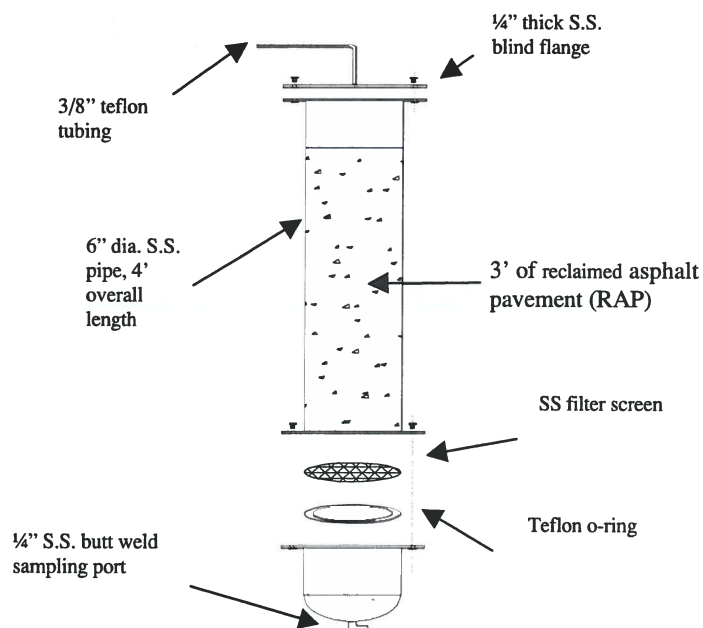
**Figure 3.3 Typical Leaching Column (Lysimeter)**

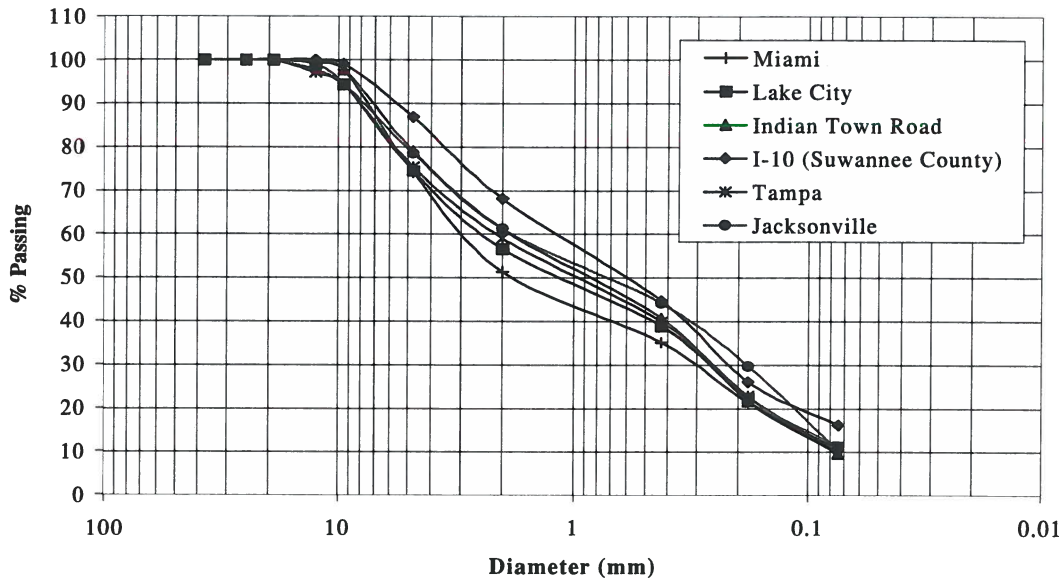
Figure 4.1 Grain Size Distribution

highways in Florida and the design mix for these roadways should have been similar. These results show that all samples were of comparable gradation and that there was little physical difference between them. The individual gradation results are presented in Appendix A.

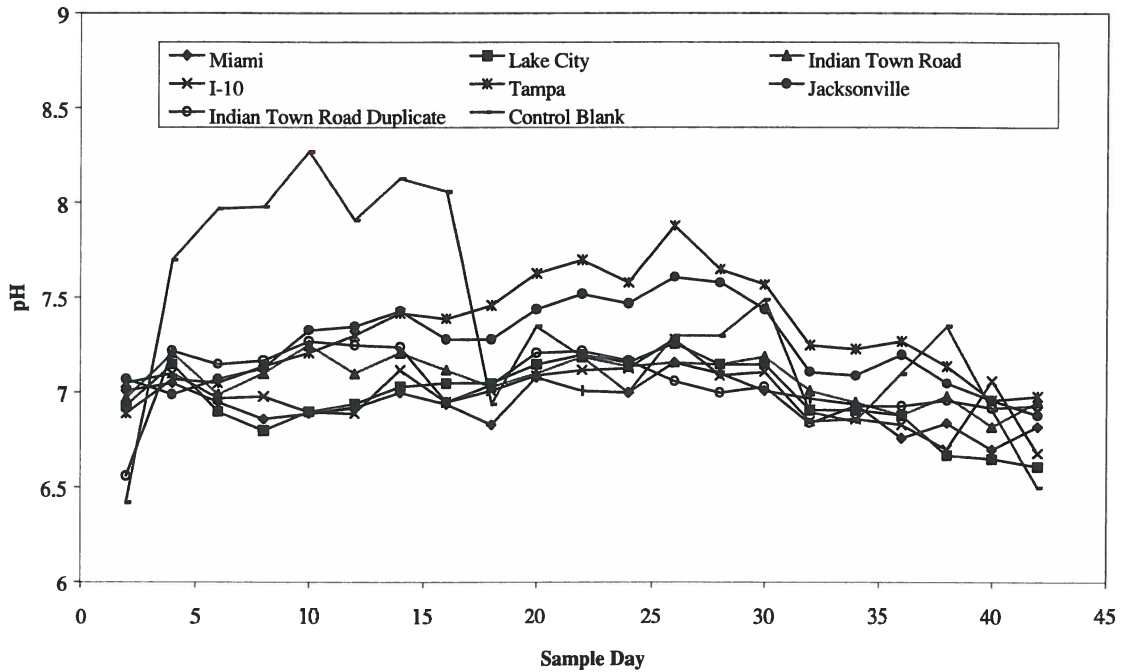
**Figure 4.2 Unsaturated pH vs. Time**

rainwater has a slightly acidic pH, the actual solution conditions in a RAP stockpile will be neutral from carbonate alkalinity in the aggregate.

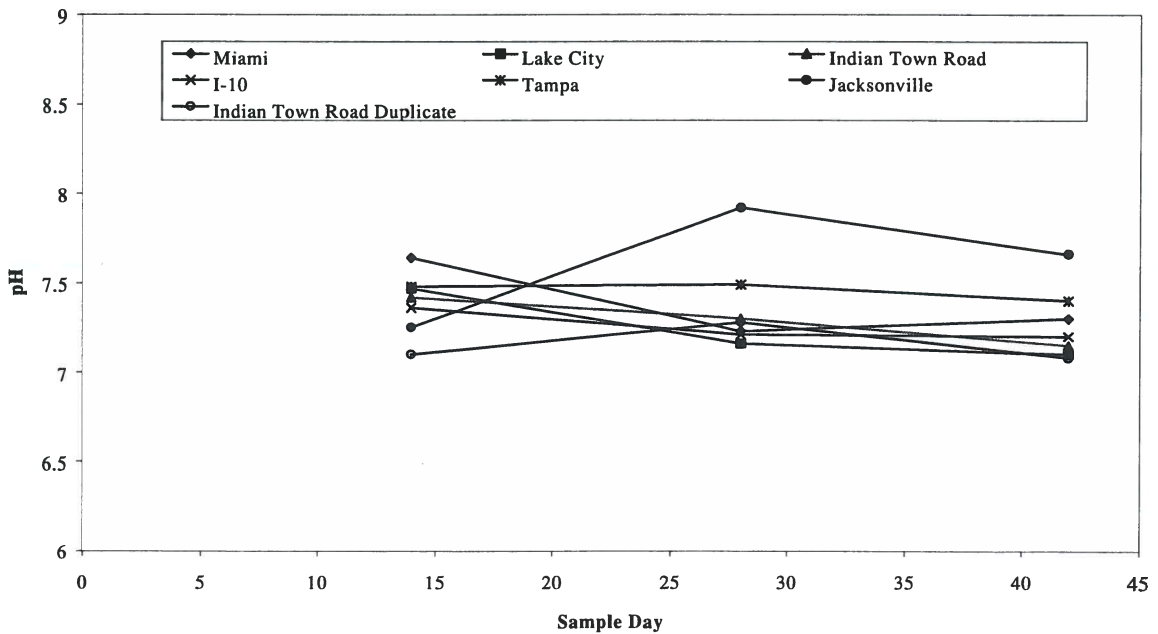
**Figure 4.3 Saturated pH vs. Time**

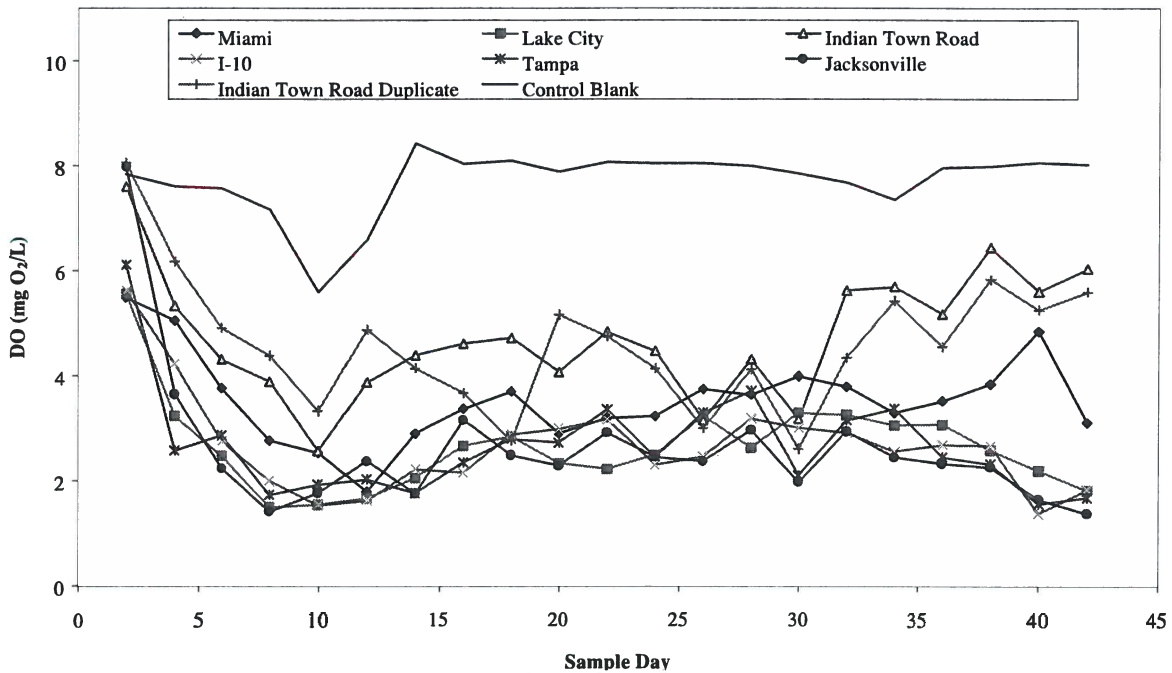
**Figure 4.4 Unsaturated DO vs. Time**

Figure 4.4 and Figure 4.5 show the DO measurements for the unsaturated and saturated lysimeters. DO is a measurement of the dissolved oxygen in the leachate.

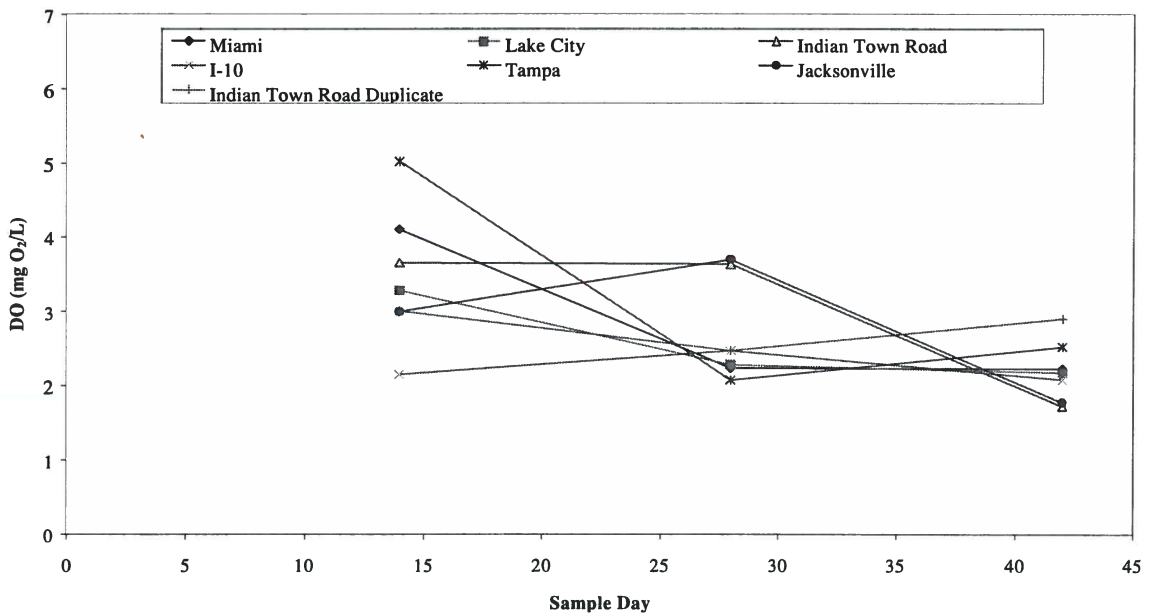
**Figure 4.5 Saturated DO vs. Time**

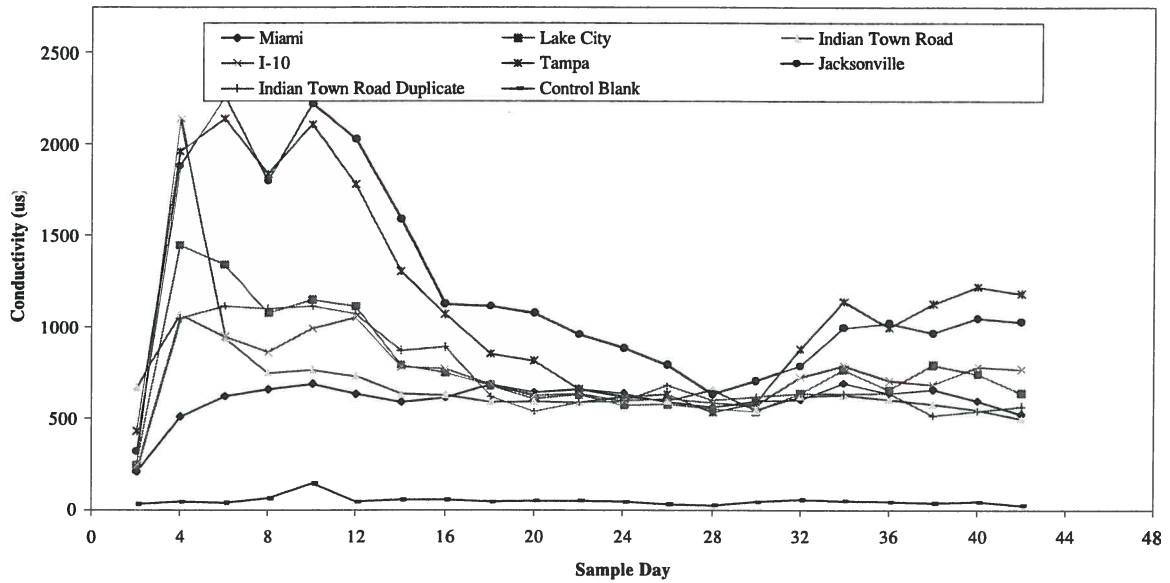
Figure 4.6 Unsaturated Conductivity vs. Time

Figure 4.6 and Figure 4.7 show the conductivity of the leachate samples over time. The conductivity was used to measure the dissolved ion species in the leachate solution.

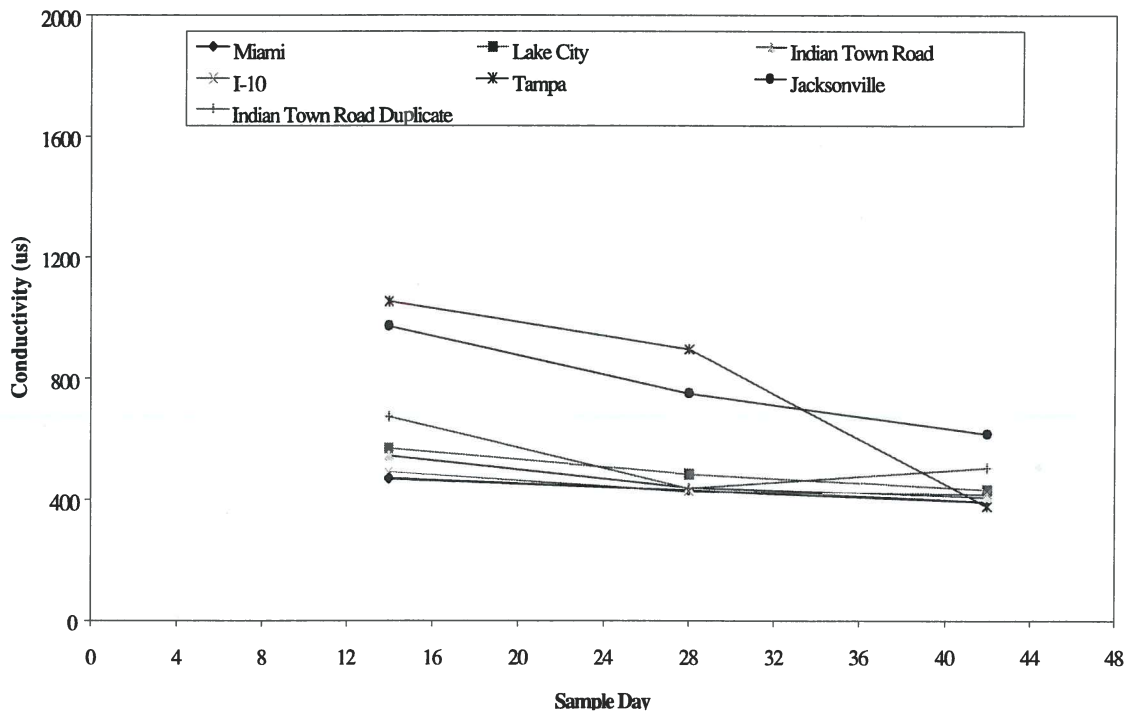
Figure 4.7 Saturated Conductivity vs. Time

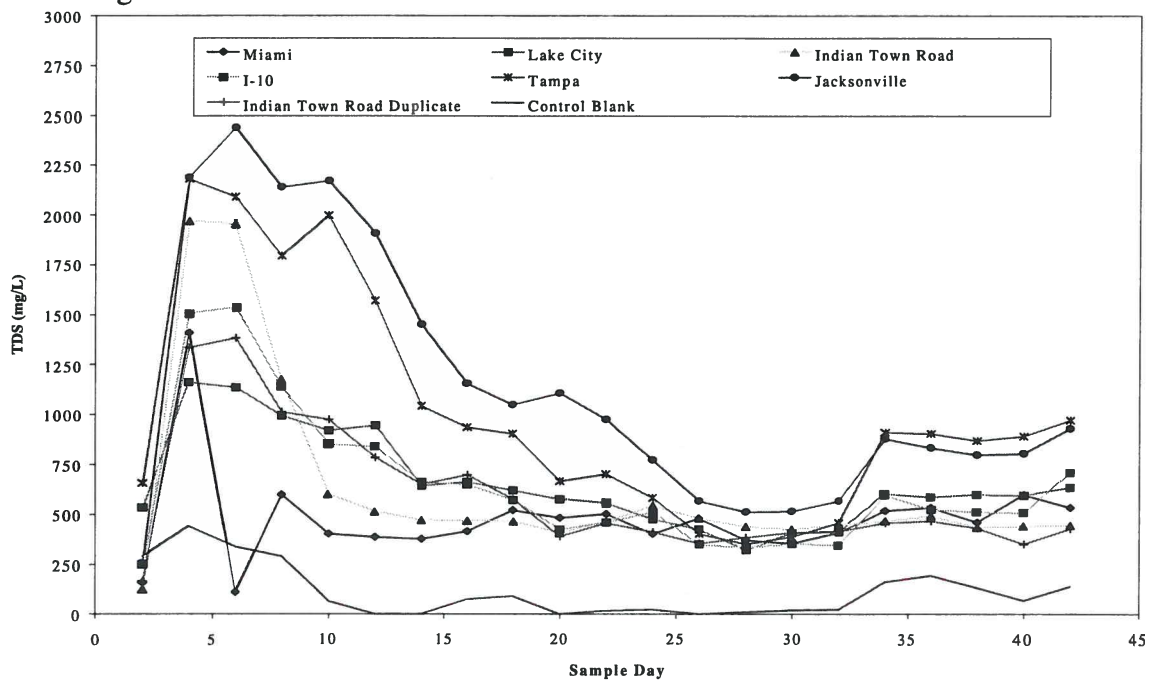
Figure 4.8 Unsaturated TDS vs. Time

Laboratory tests were then performed to test for TDS, alkalinity, COD, and NPOC. Figure 4.8 and Figure 4.9 show the results for unsaturated and saturated TDS.

All RAP samples reached TDS measurements above the secondary drinking water standard of 500 mg/L. As will be seen later, the TDS was a result of mineral leaching from the aggregate, and would be similar to any limestone aggregate. The saturated columns also illustrated a decrease in TDS over time. Both saturated and unsaturated columns had measurements above the secondary drinking water limits of 500 mg/L. The results for alkalinity are presented in Figure 4.10 and 4.11.

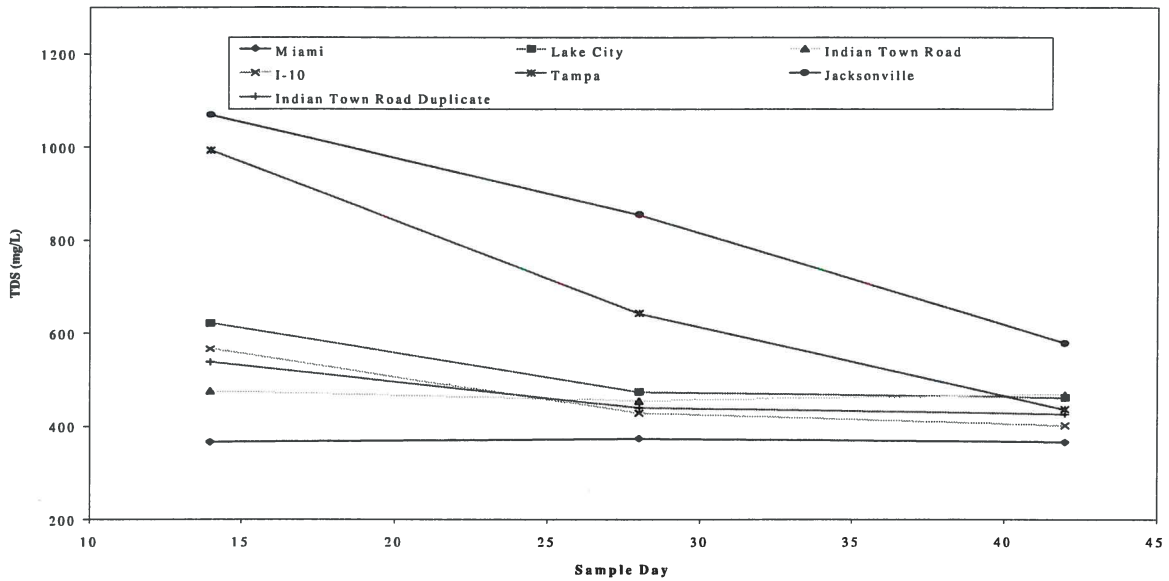
**Figure 4.9 Saturated TDS vs. Time**

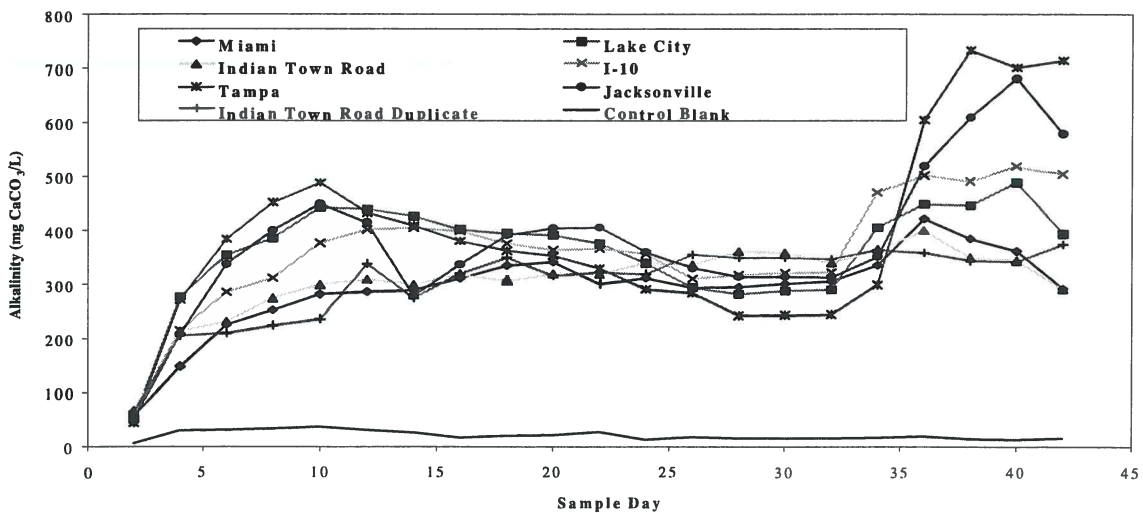
**Figure 4.10 Unsaturated Alkalinity vs. Time**

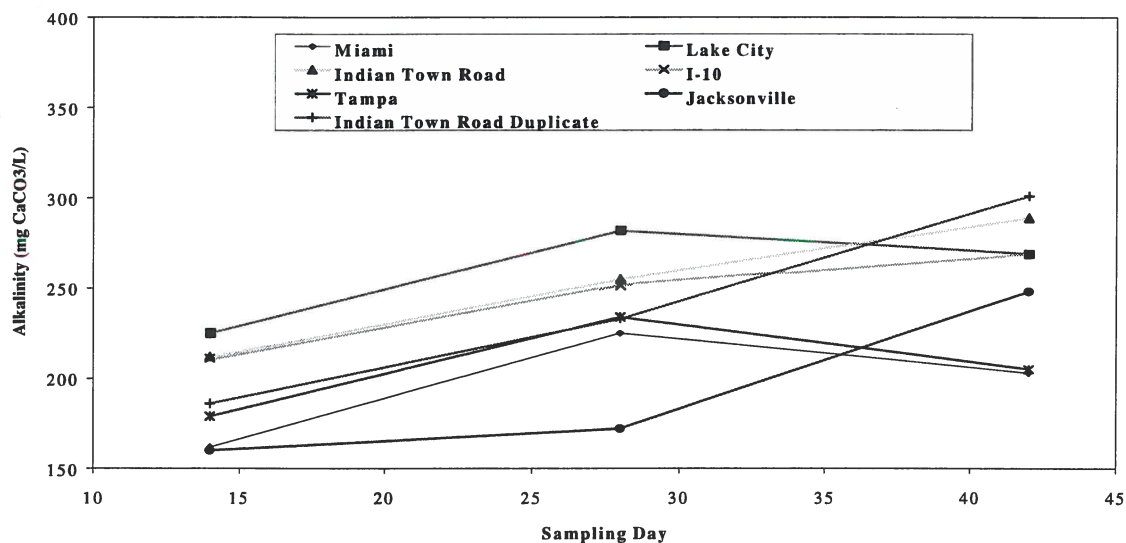
**Figure 4.11 Saturated Alkalinity vs. Time**

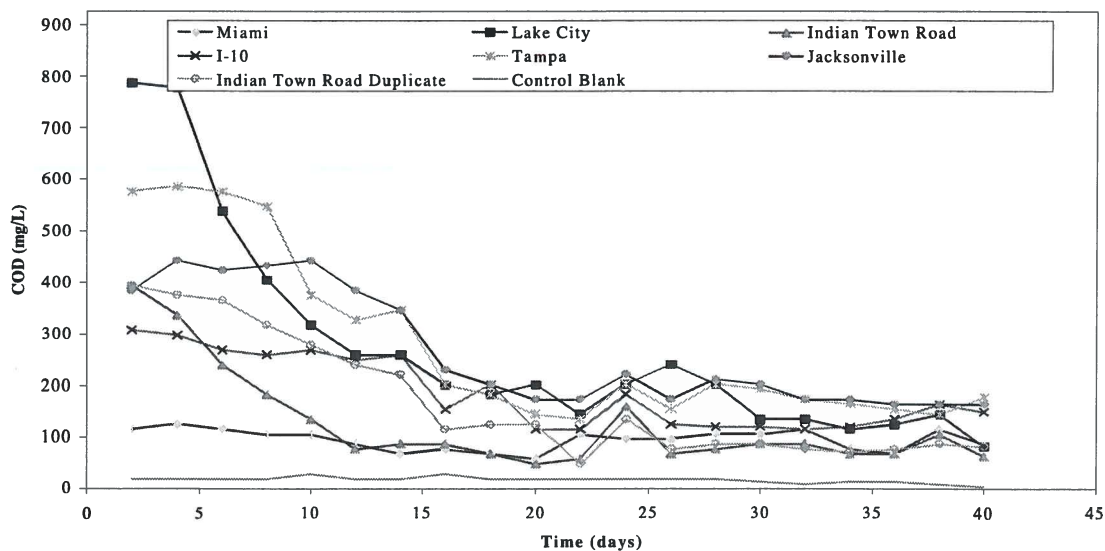
**Figure 4.12 Unsaturated COD vs. Time**

Figure 4.12 and Figure 4.13 display the COD results for the unsaturated and saturated lysimeters. COD measurements were useful in estimating the amount of organics in the leachate.

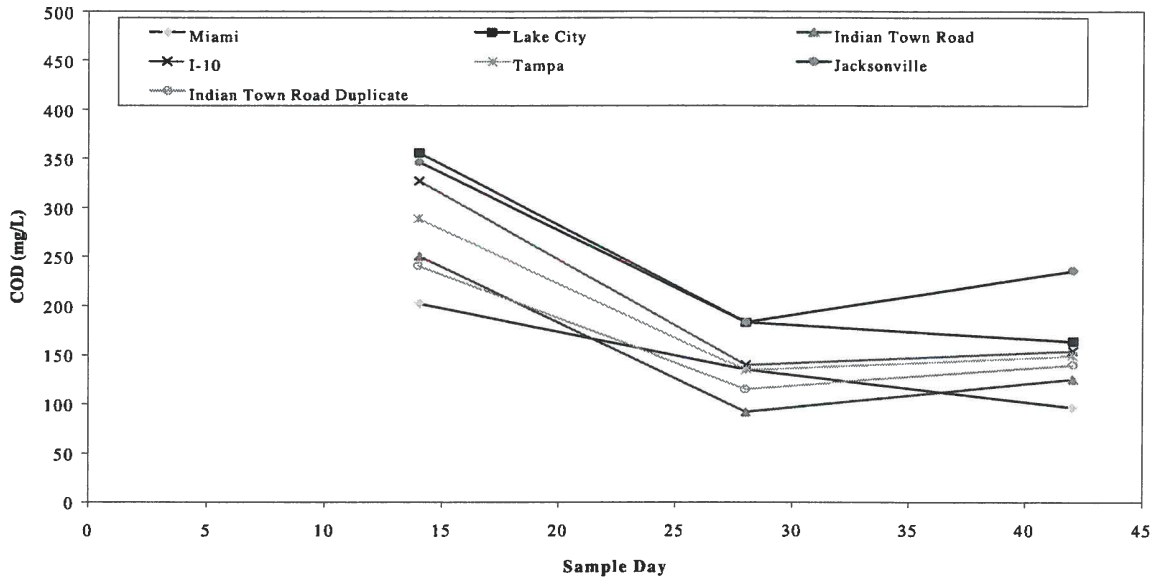
**Figure 4.13 Saturated COD vs. Time**

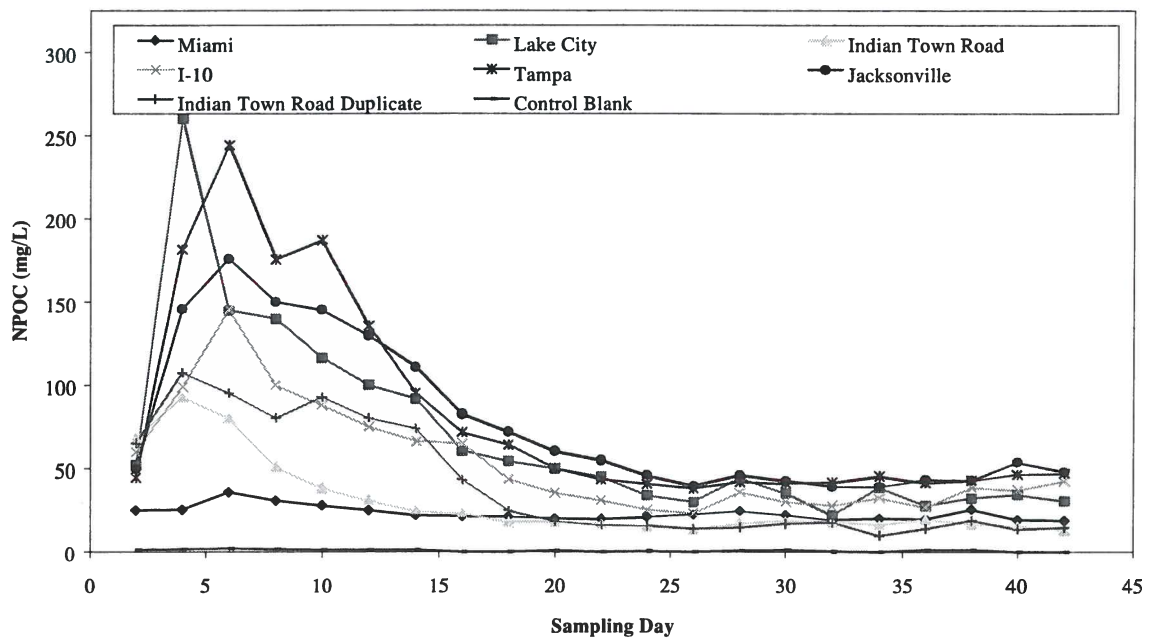
Figure 4.14 Unsaturated NPOC vs. Time

NPOC results are illustrated in Figure 4.14 and Figure 4.15. NPOC was also used to estimate the amount of organic material in the leachate samples. The trend illustrated with NPOC results were similar the COD results, as was expected. The unsaturated column illustrated the leaching curve and the saturated column decreased over the sampling period. Although some organic matter was leached, its nature was not characterized. Priority pollutant organic compounds are discussed in the next section.

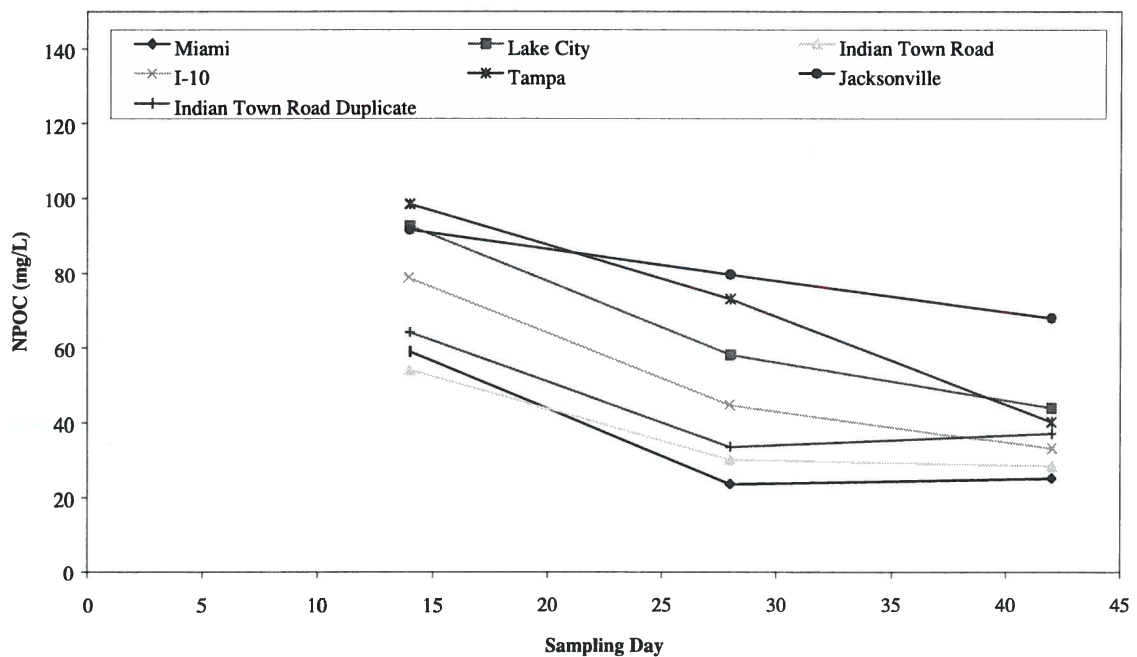
Figure 4.15 Saturated NPOC vs. Time

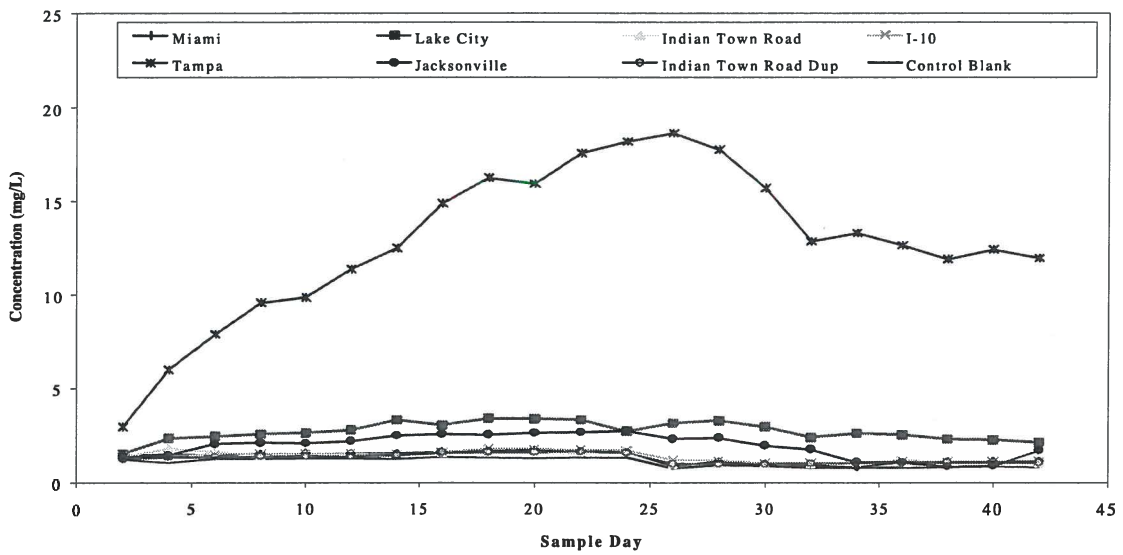
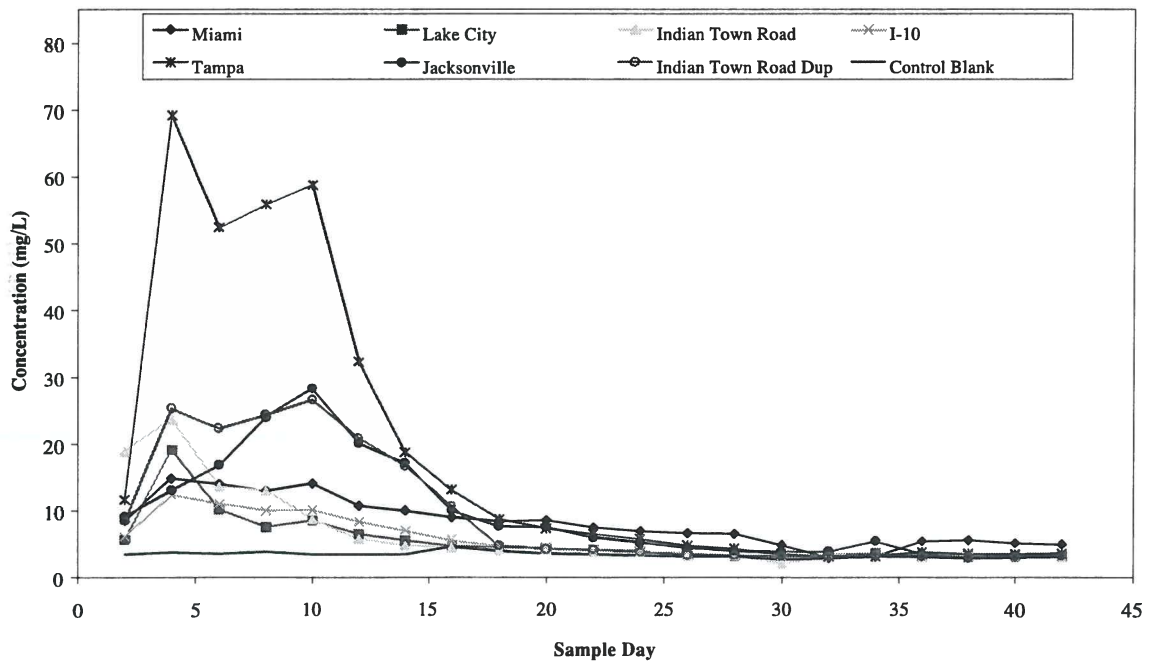
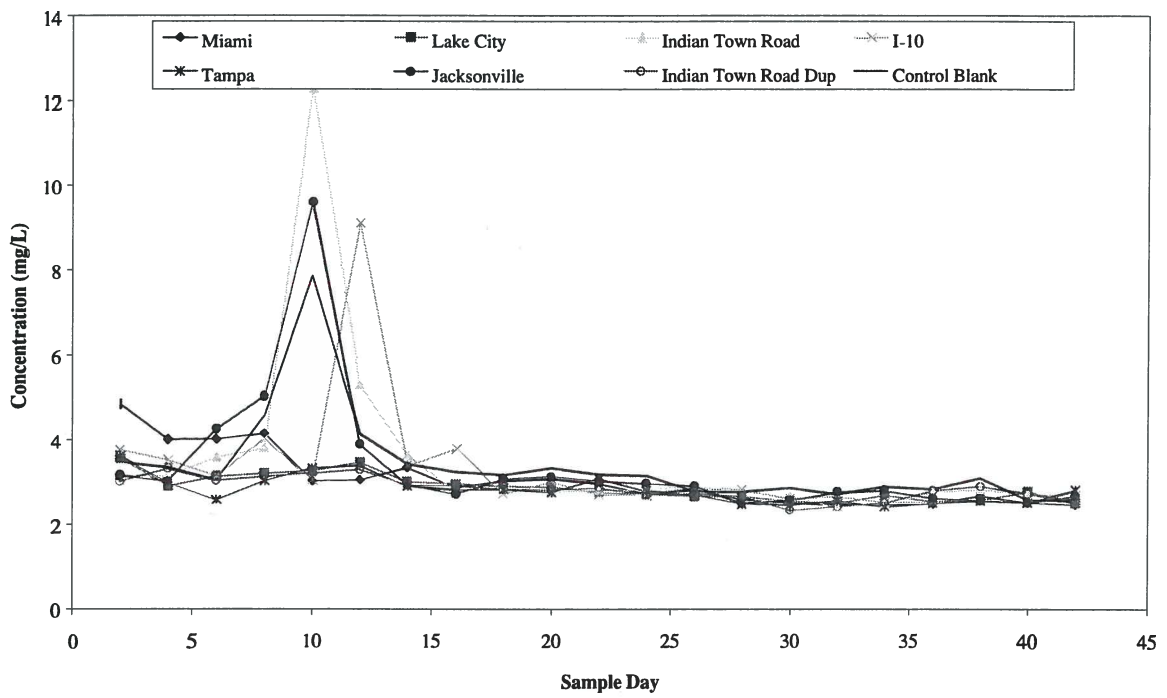
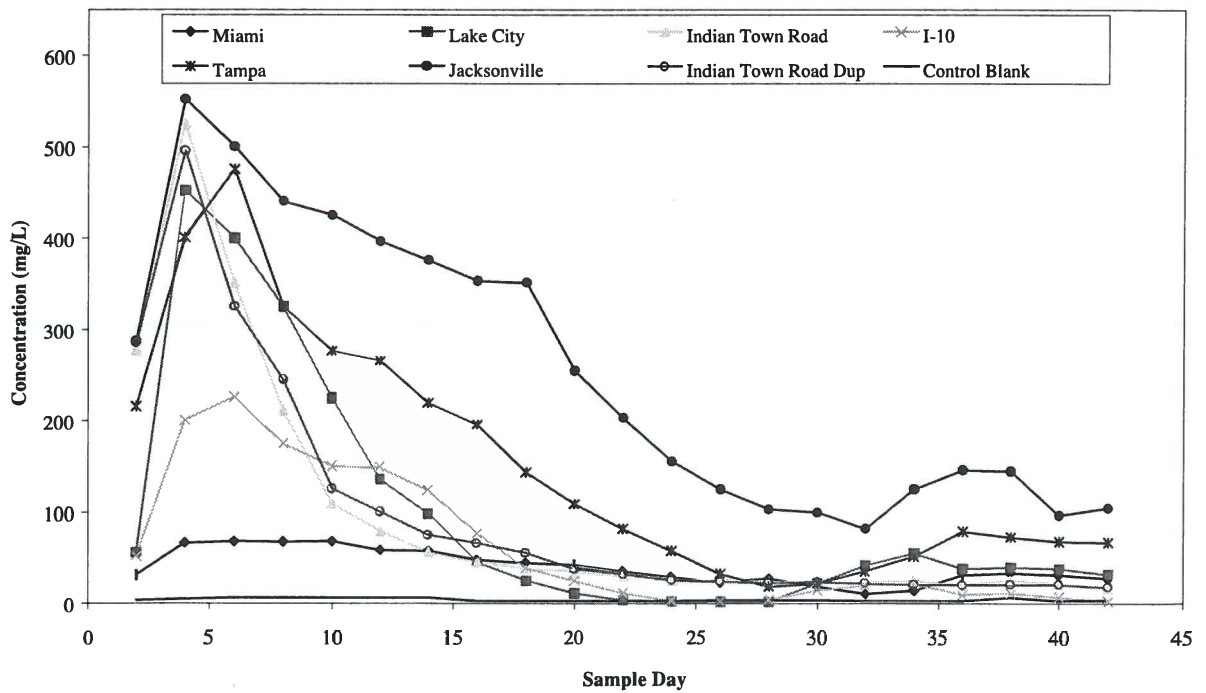
Figure 4.16 Unsaturated Fluoride vs. Time

Figure 4.17 Unsaturated Chloride vs. Time

Figure 4.18 Unsaturated Nitrate vs. Time

Figure 4.19 Unsaturated Sulfate vs. Time

illustrate the results for anion analysis. Figure 4.20 through Figure 4.23 and Figure 4.28 through Figure 4.31 illustrate the results for cation analysis.
