# Franklin County Board of Zoning Appeals

**MINUTES OF THE  
FRANKLIN COUNTY BOARD OF ZONING APPEALS**

## CU-3922

# **Leaching Characteristics of Asphalt Road Waste**

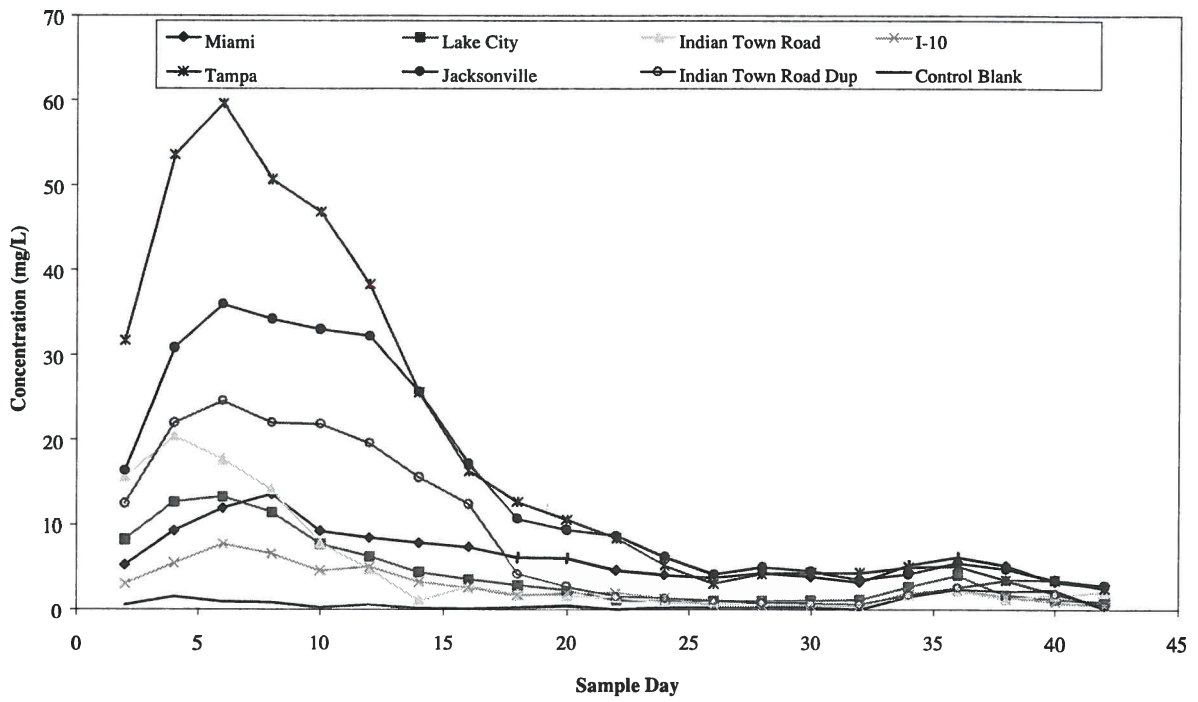
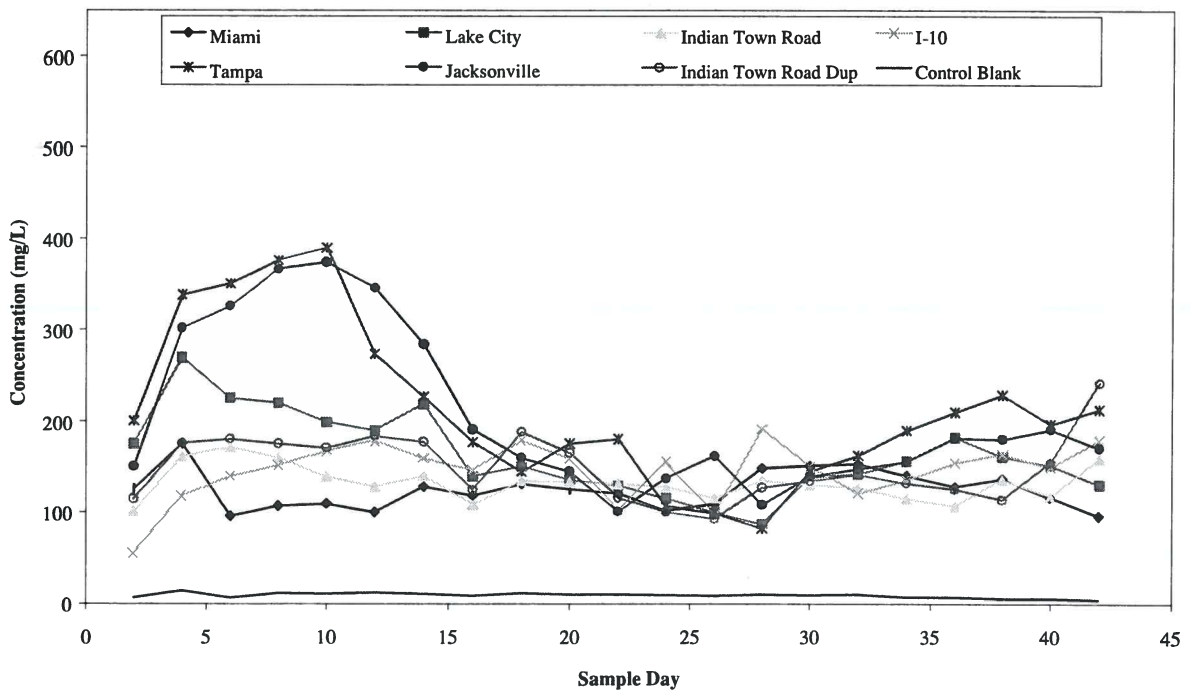
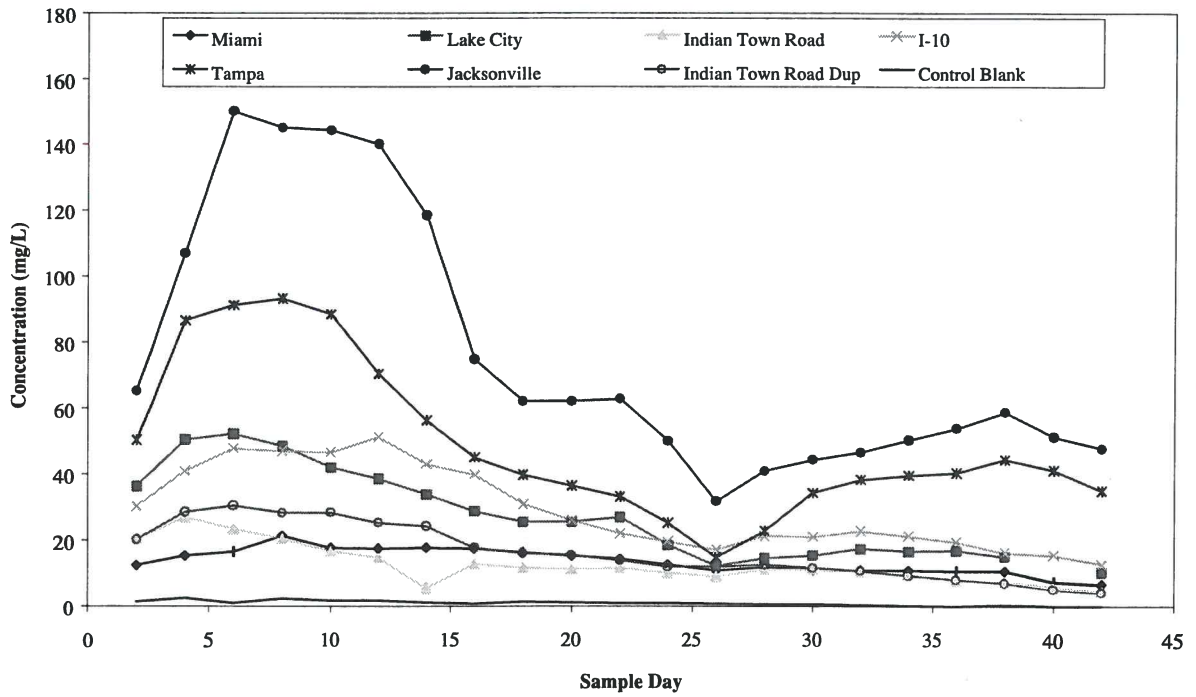
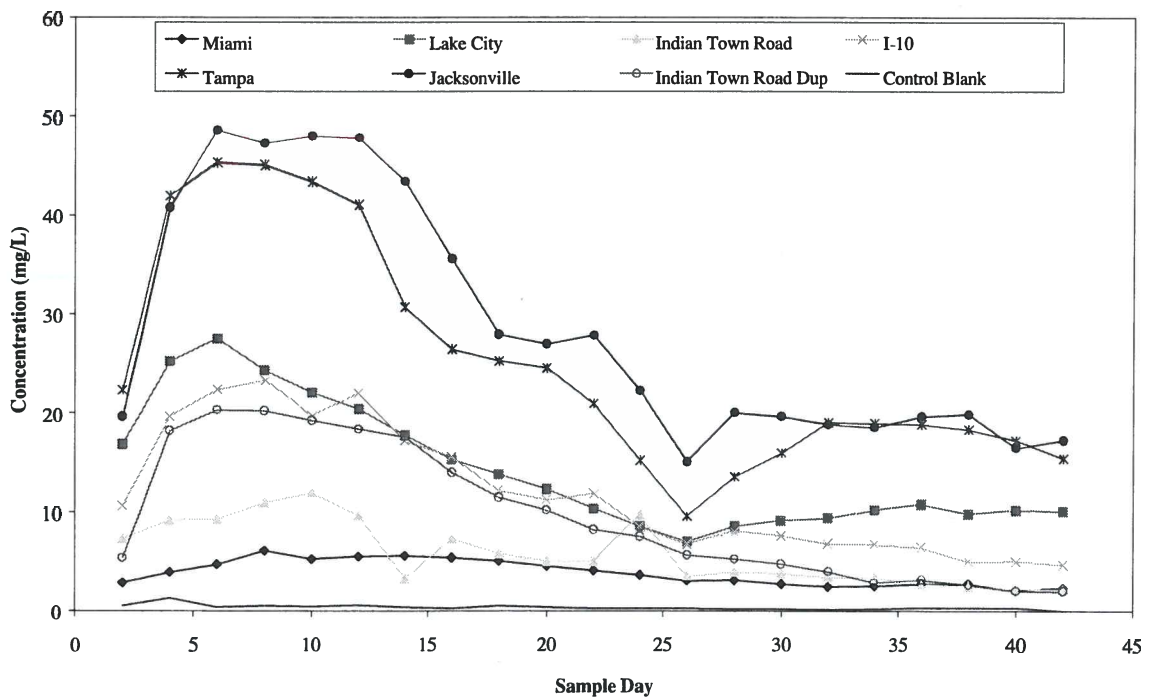
**Figure 4.20 Unsaturated Sodium vs. Time**

**Figure 4.21 Unsaturated Calcium vs. Time**

Figure 4.22 Unsaturated Magnesium vs. Time

Figure 4.23 Unsaturated Potassium vs. Time

illustrate the results for anion analysis. Figure 4.20 through Figure 4.23 and Figure 4.28 through Figure 4.31 illustrate the results for cation analysis.

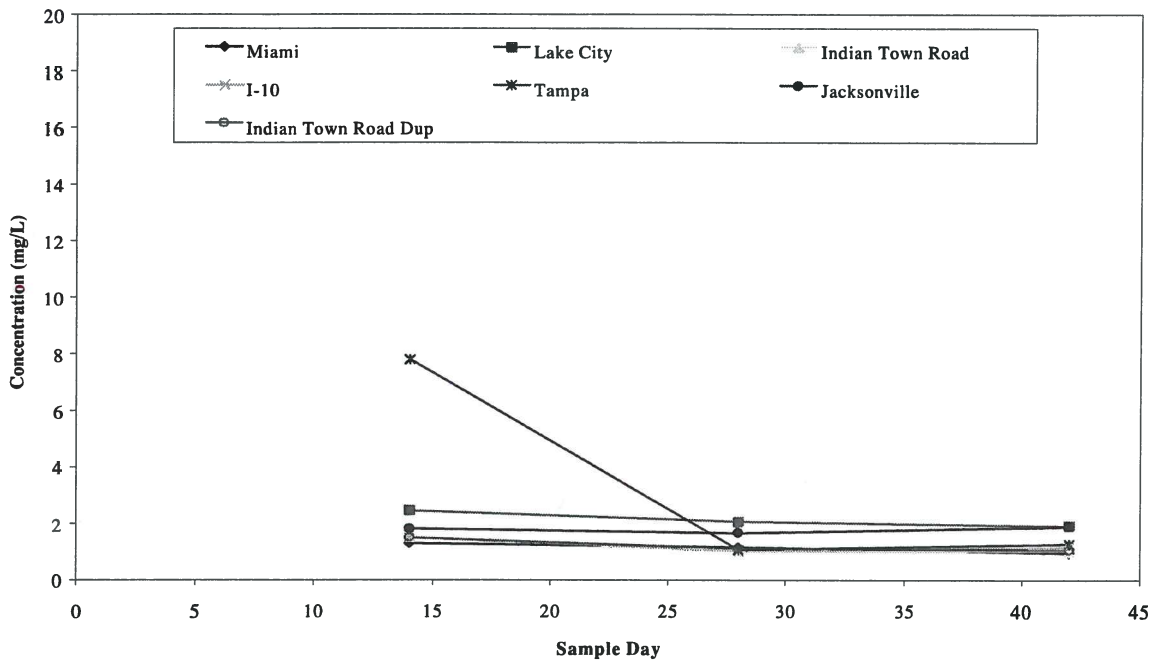
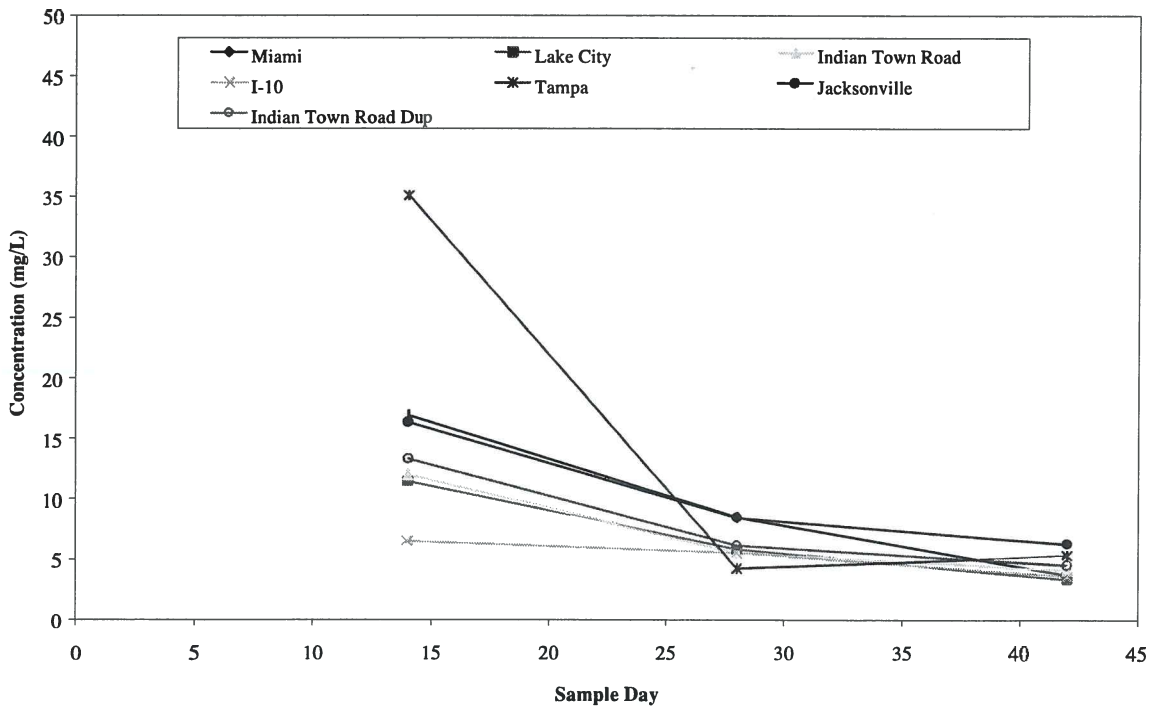
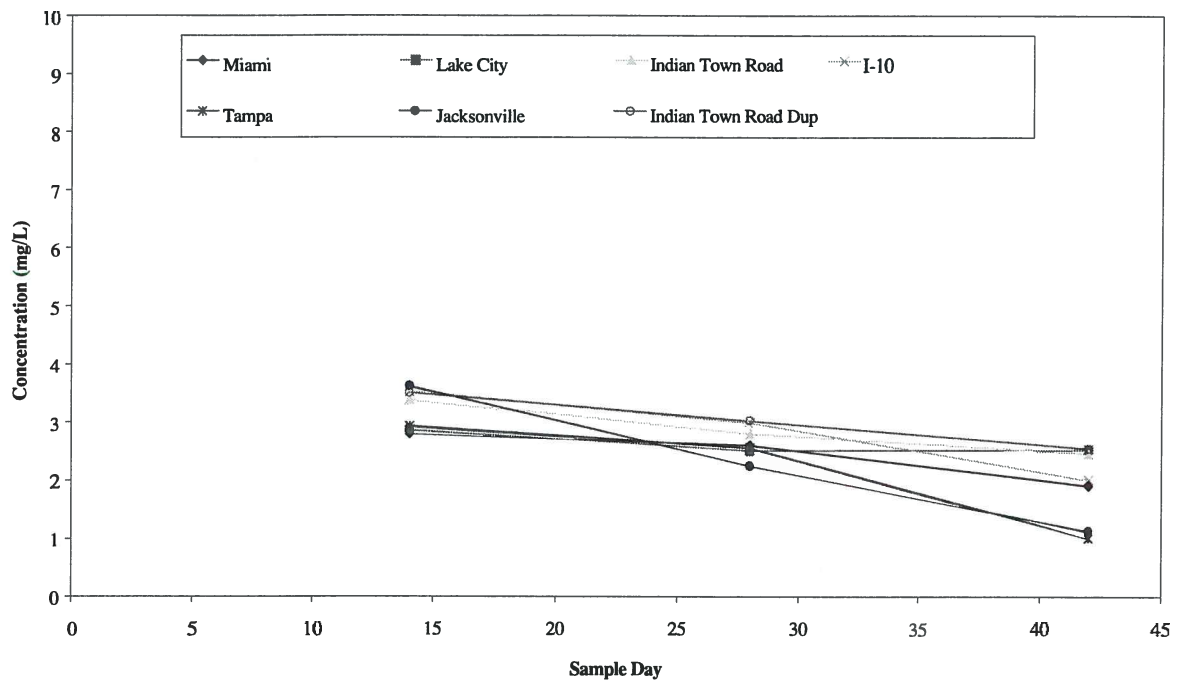
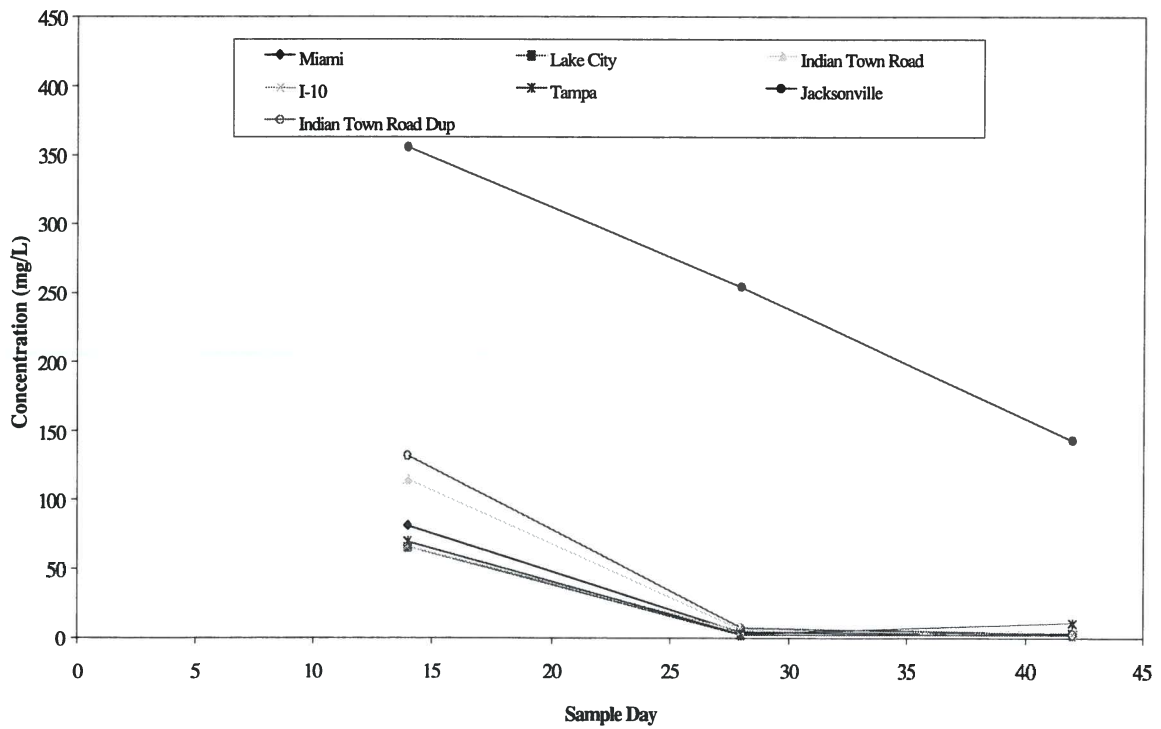
Figure 4.24 Saturated Fluoride vs. Time

Figure 4.25 Saturated Chloride vs. Time

Figure 4.26 Saturated Nitrate vs. Time

Figure 4.27 Saturated Sulfate vs. Time

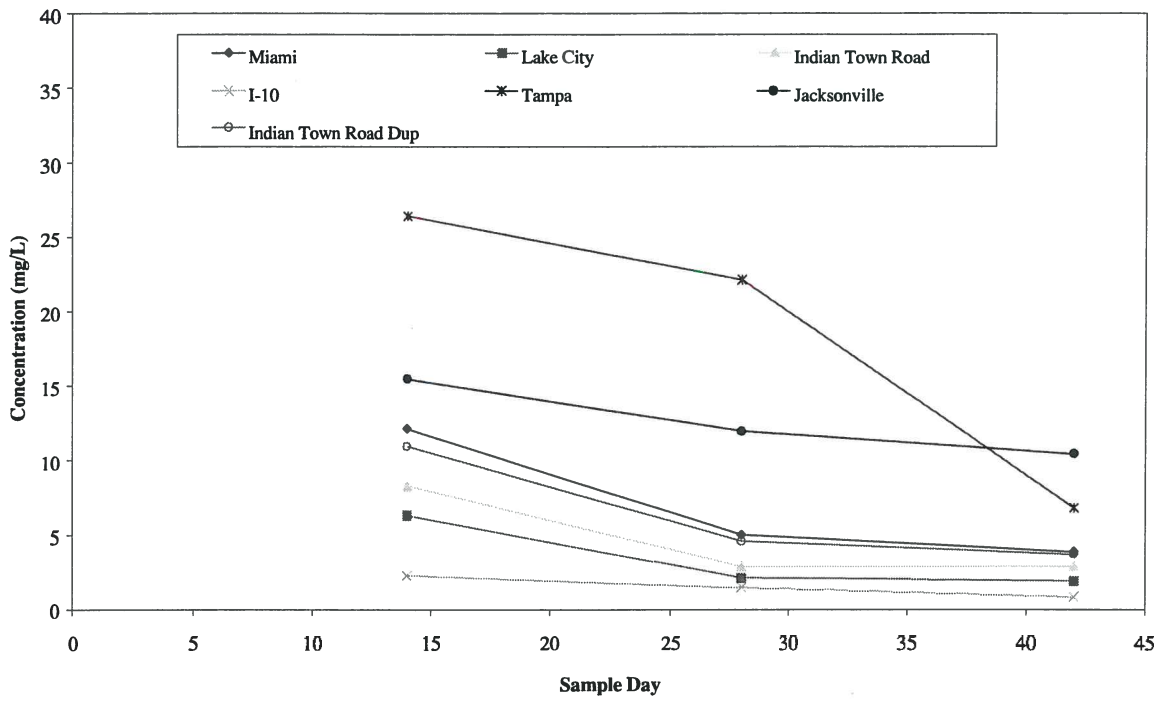
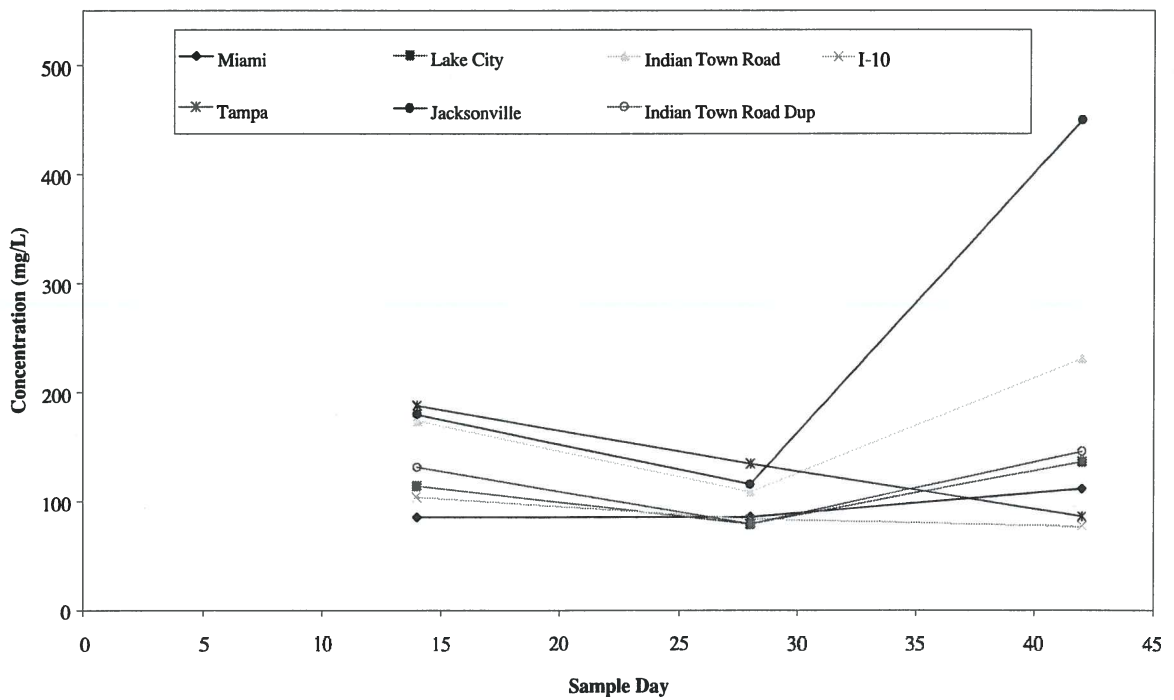
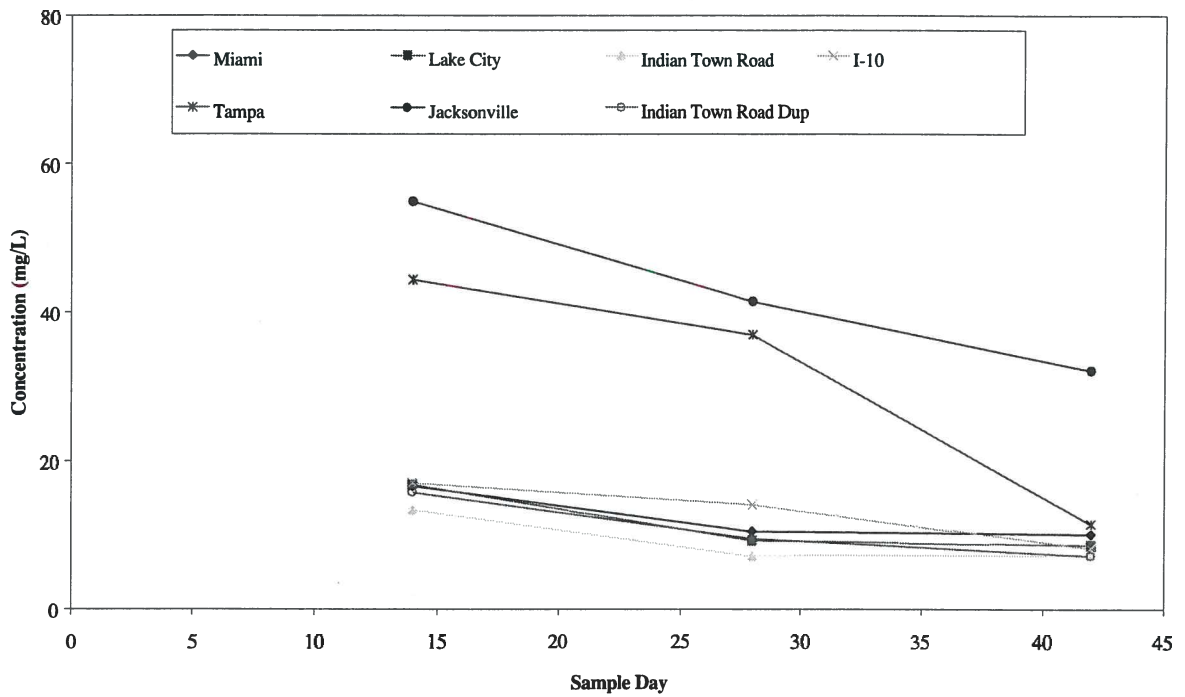
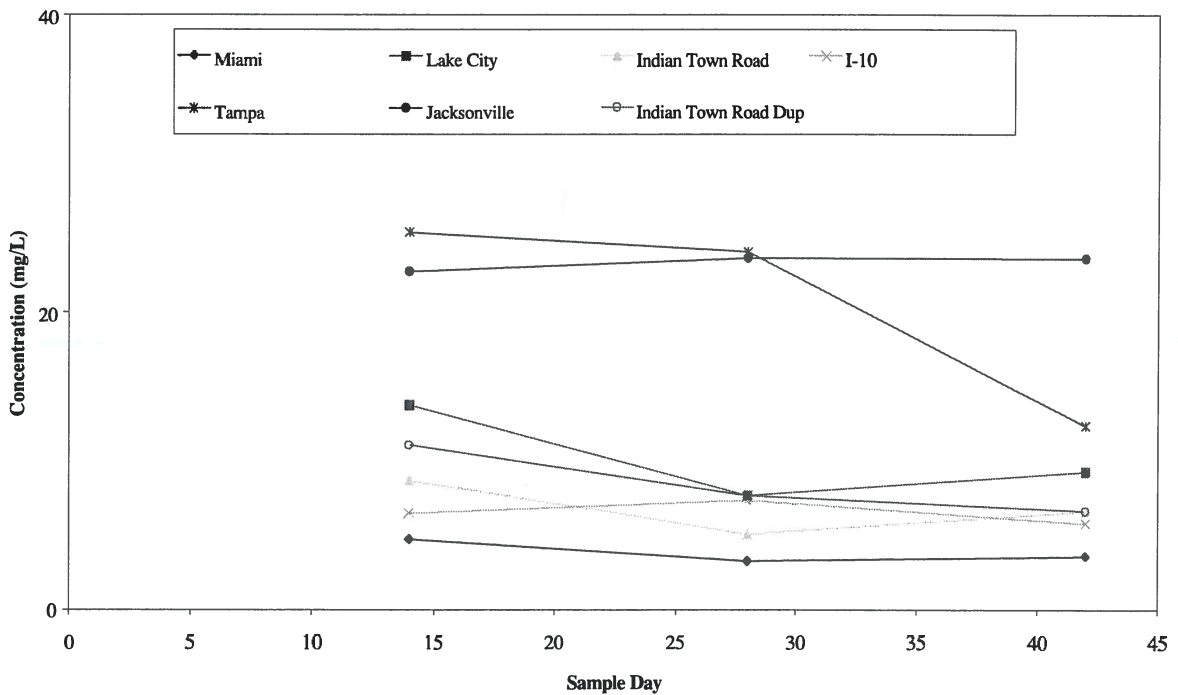
**Figure 4.28 Saturated Sodium vs. Time**

**Figure 4.29 Saturated Calcium vs. Time**

Figure 4.30 Saturated Magnesium vs. Time

Figure 4.31 Saturated Potassium vs. Time

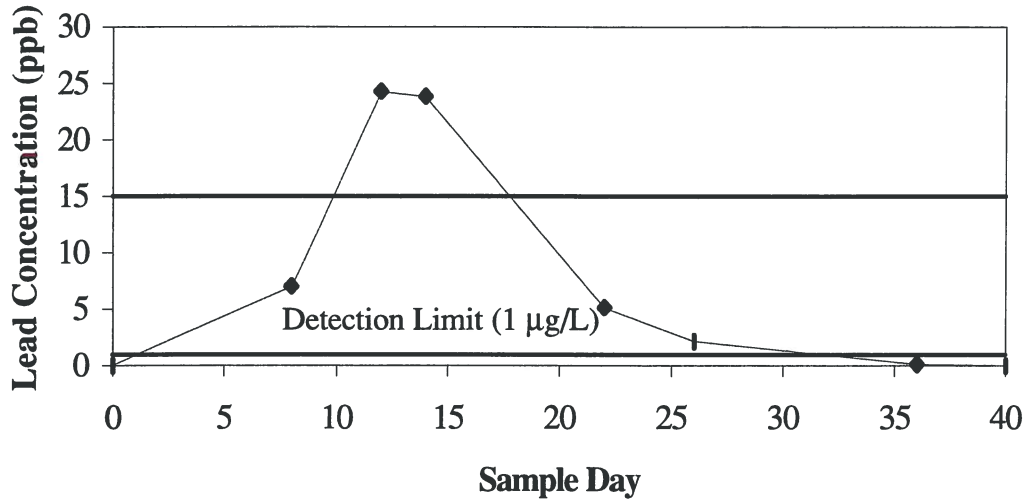
Figure 4.32 Lead Leaching Curve

The fact that lead was observed in the column and not in the batch test was a result of the dilution associated with each test. The batch tests used a 20 to 1 ratio of leaching solution to waste material. The ratios used in the column tests reported here were 0.257-to-1 for saturated conditions and 0.0367-to-1 for unsaturated conditions. When waste is applied in the environment, dilution and attenuation of chemicals in the leachate occur in most scenarios. Batch tests are typically compared to groundwater standards directly because a degree of dilution is already incorporated. With column tests, a dilution attenuation factor is typically applied to leachate concentrations to more accurately gage the impact of the waste material on groundwater quality.

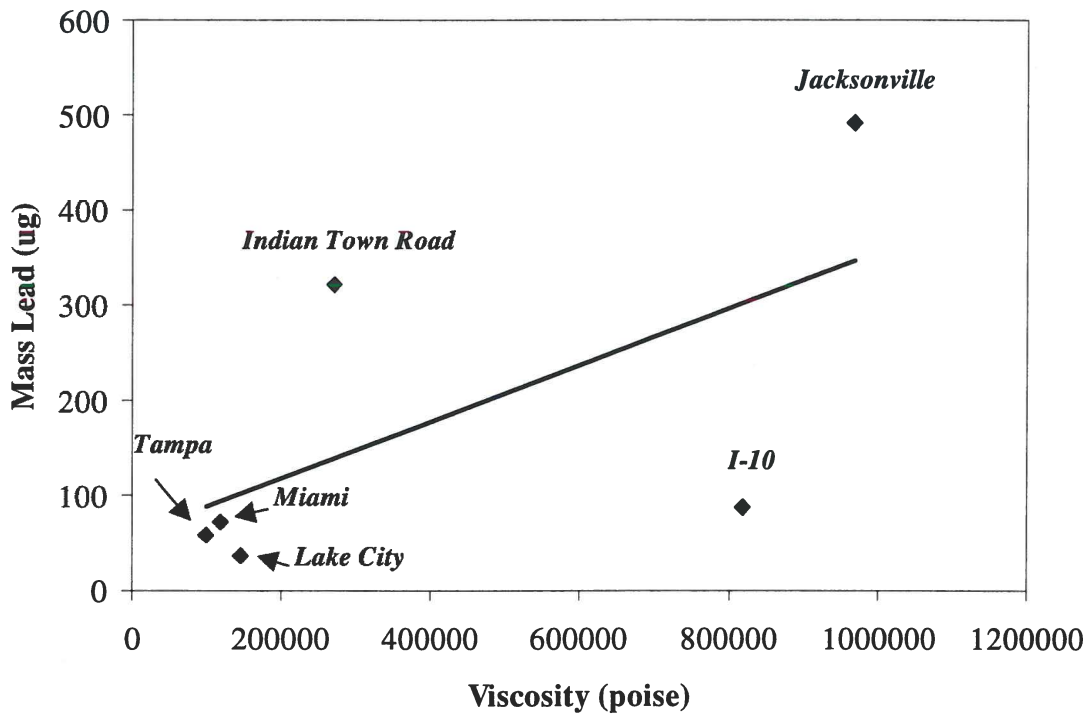
Figure 4.33 Viscosity vs. Total Lead ( $\mu\text{g}$ ) Leached in Saturated Columns

The Jacksonville site, which has the highest viscosity, had the highest concentration of lead. Even though this was an older road, there may have been other factors involved in why lead was detected. The Jacksonville sample came from a mixed source pile. This material could have come from a parking lot or a downtown road where stop and go traffic occurred. Highways with large amounts of stop-and-go traffic would also tend to have more exposure time to spills and leaks. The I-10 sample, which has the second highest viscosity, has a very low concentration of lead. Even though I-10 is an older highway, it is a main interstate with no stop-and-go traffic.

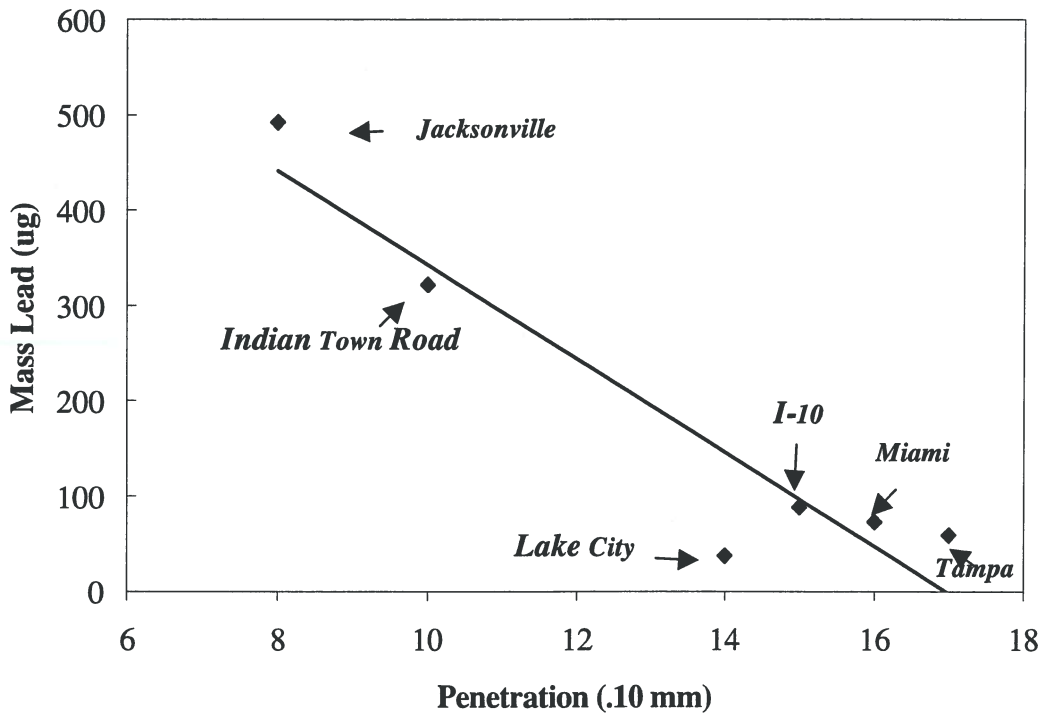
Figure 4.33 Penetration vs. Total Lead ( $\mu\text{g}$ ) Leached in Saturated Columns

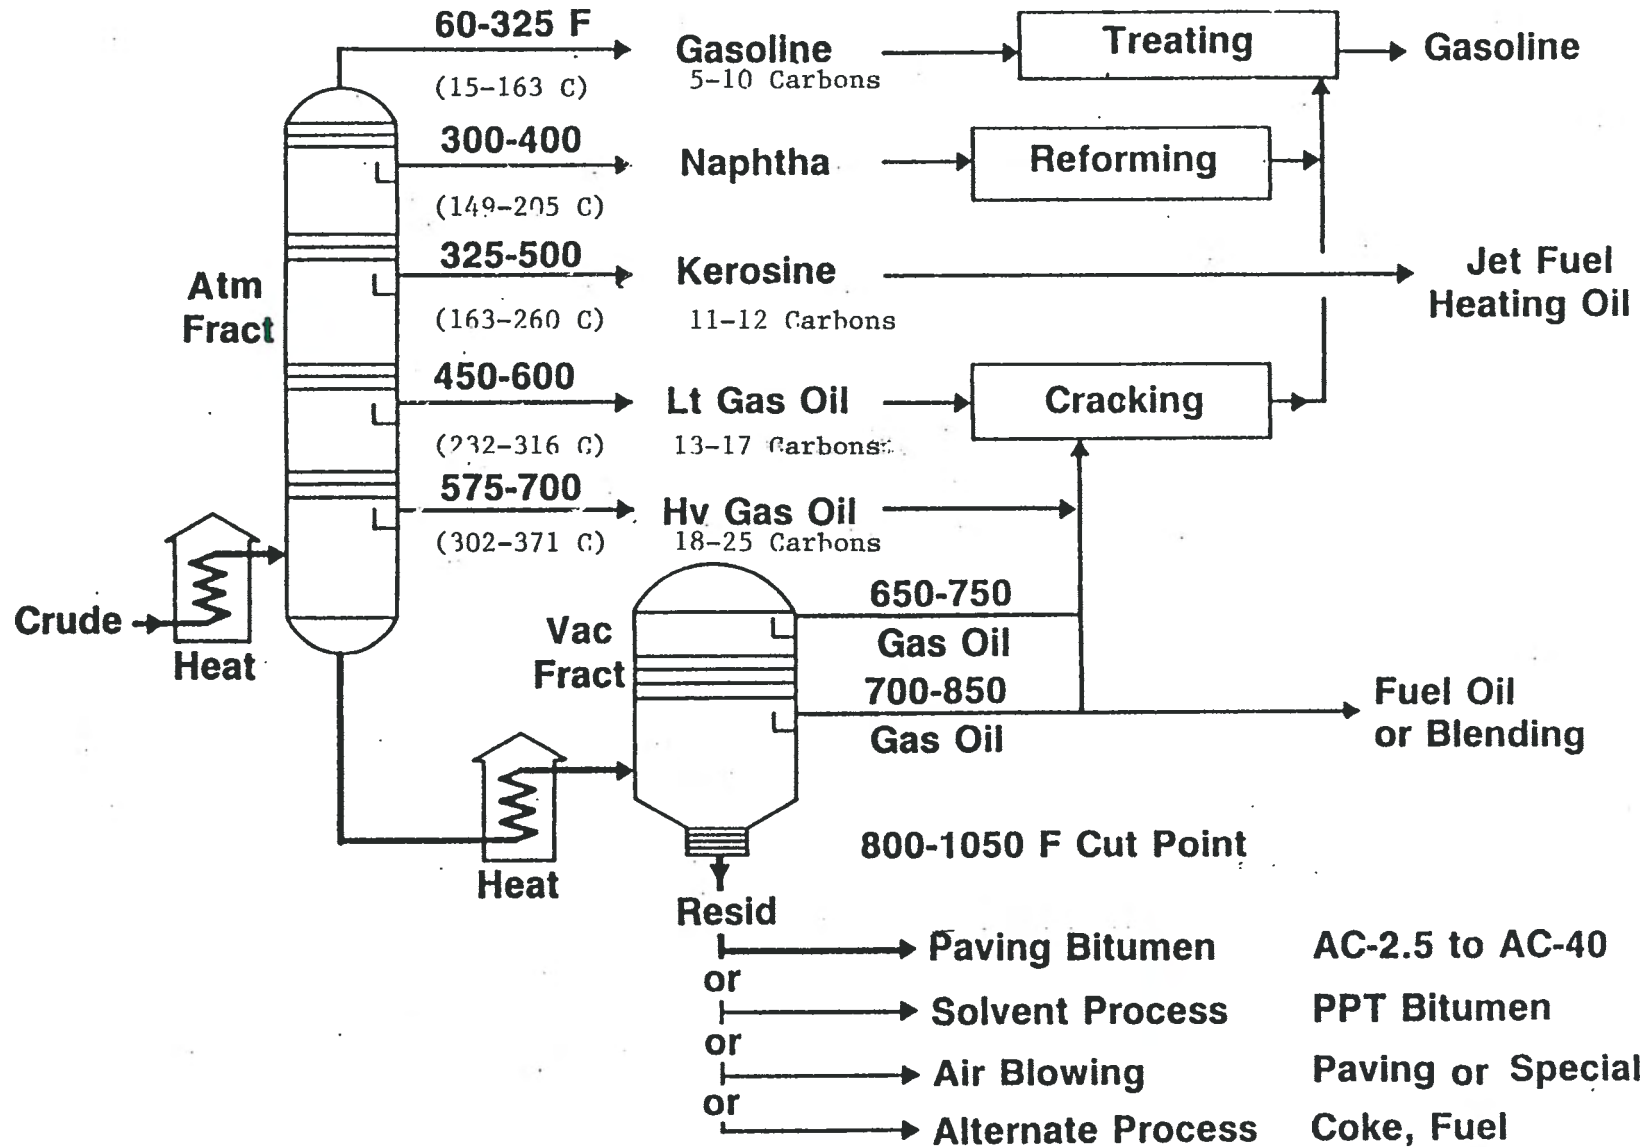
**FIGURE 1**  
**CRUDES INITIALLY SEPARATED**  
**BY DISTILLATION**

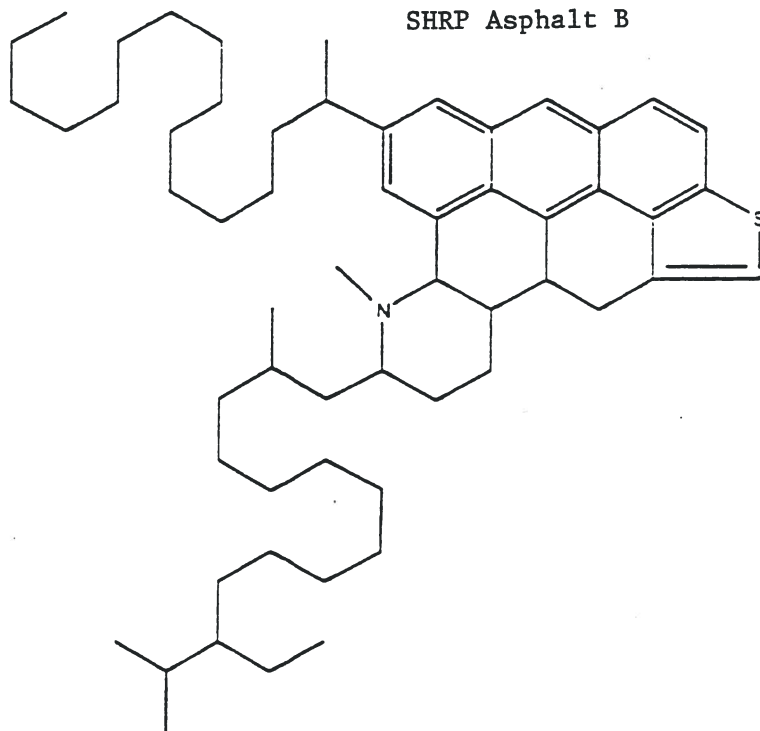
An Average Molecule of SHRP Asphalt B

conjugated systems  
(dark bonds)

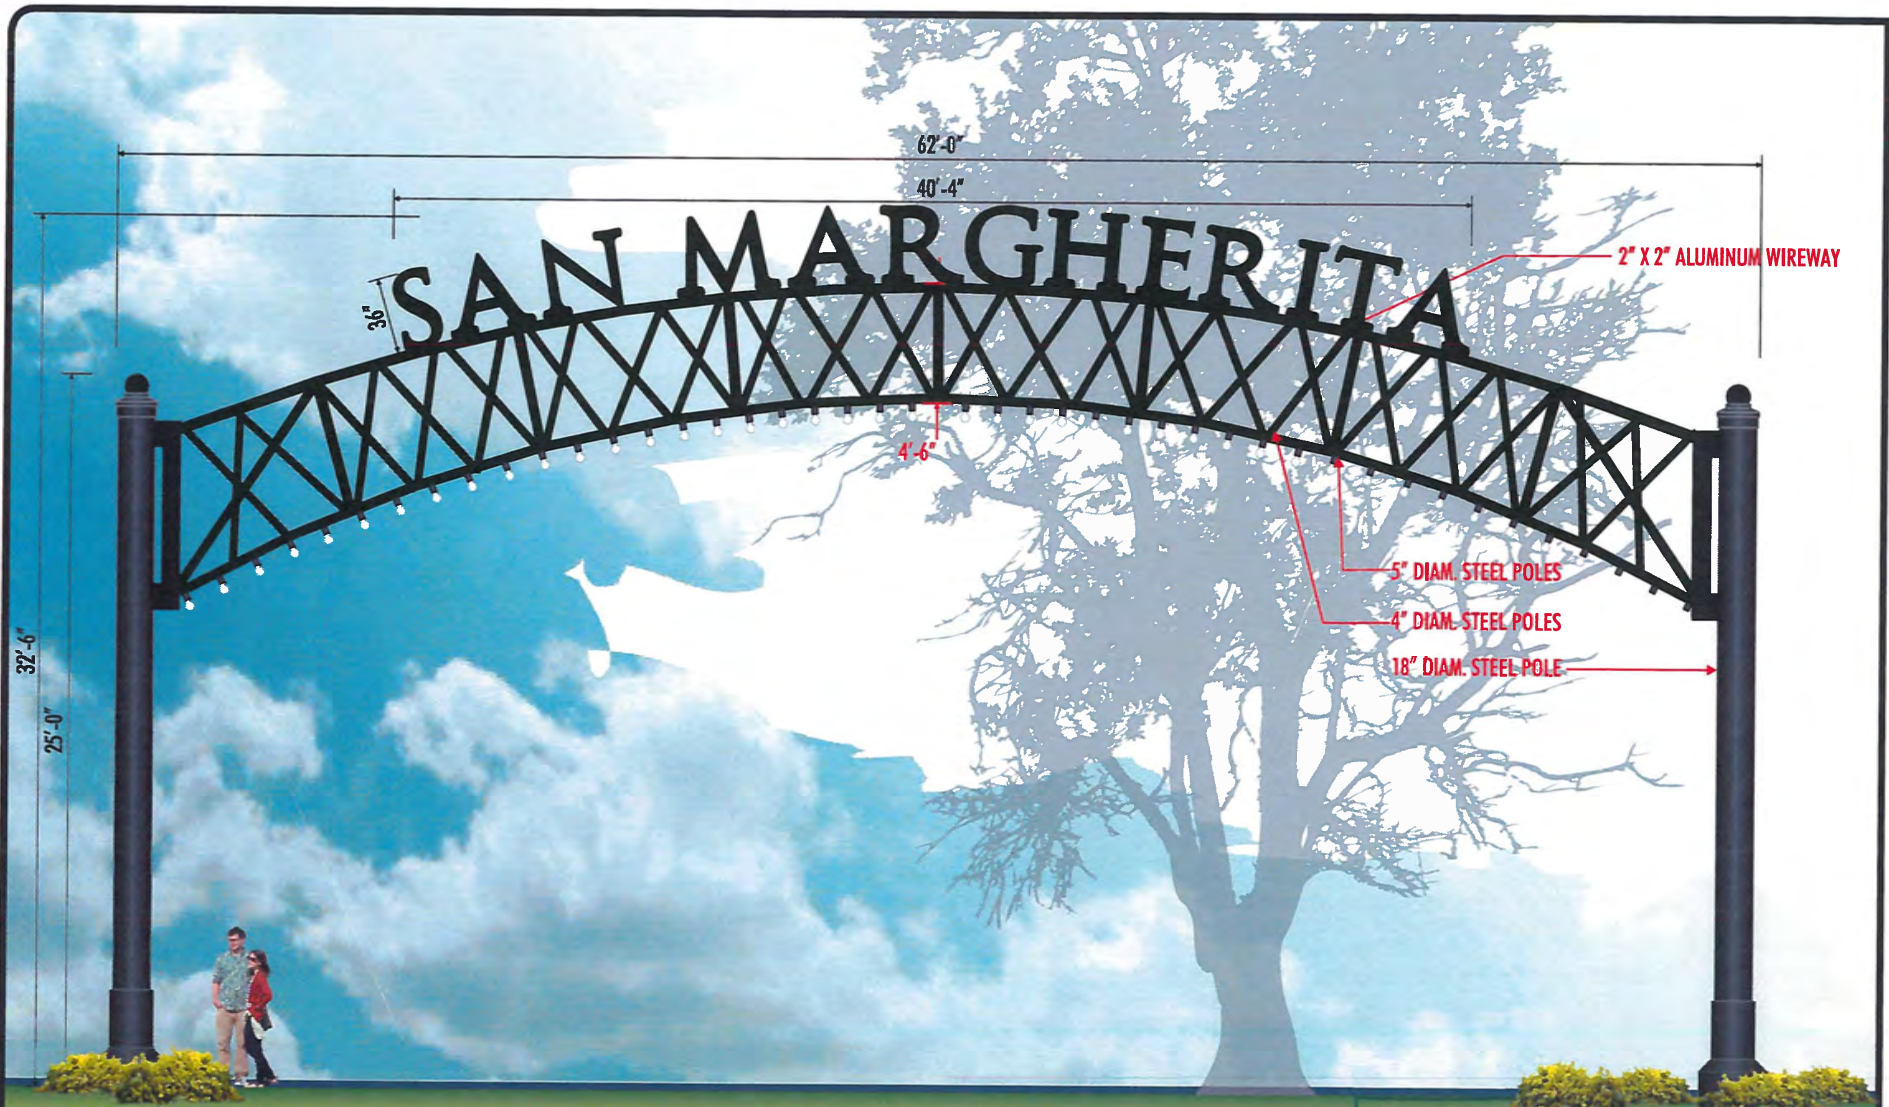
**#S1-34589-R4: ILLUMINATED STEEL ARCHWAY**  $3/16" = 1'-0"$

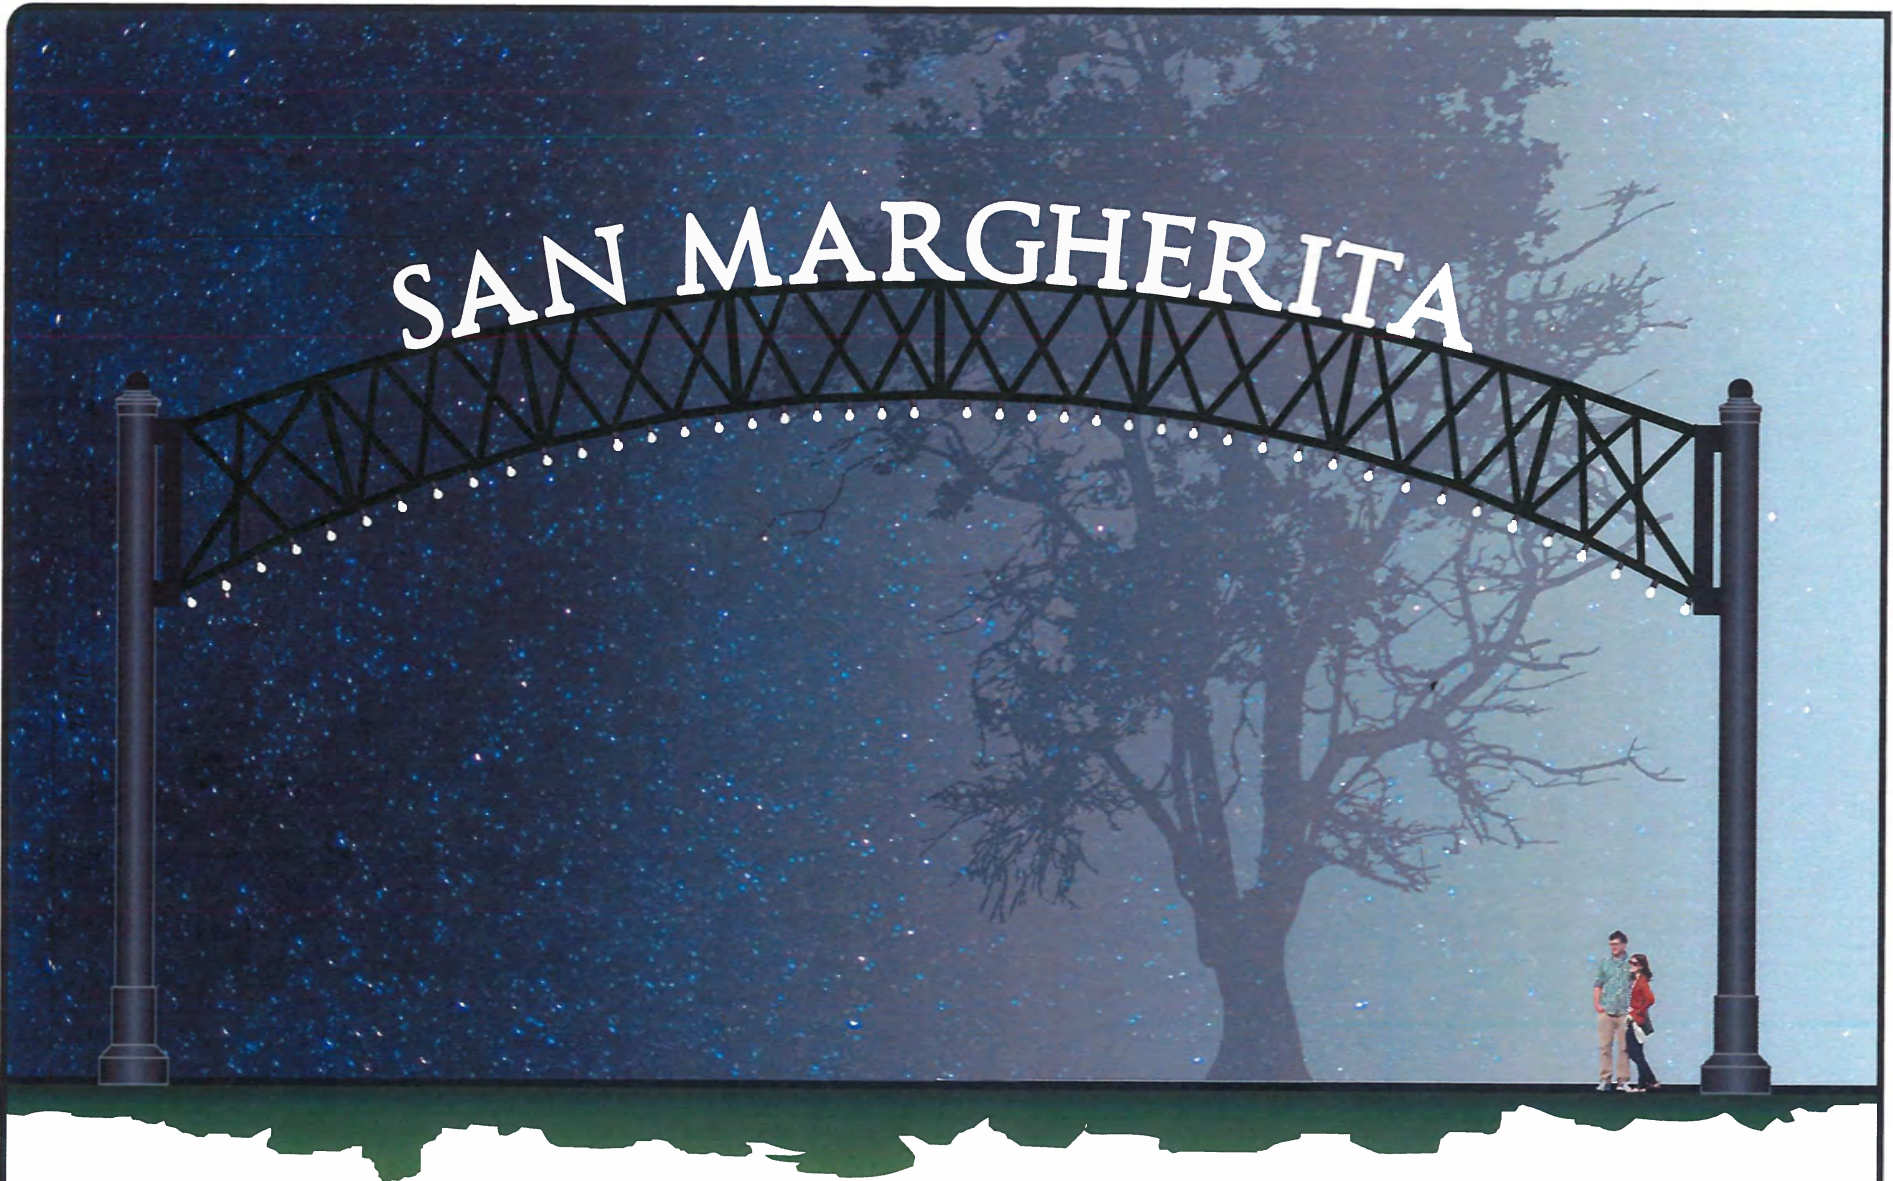
**#S1-34589-R4: ILLUMINATED STEEL ARCHWAY**      3/16" = 1'-0"
